WIMBERLEY VALLEY Cypress Creek & Blanco River

Basin Steering Committee meeting

March 20th, 2014

Water Quality Summary

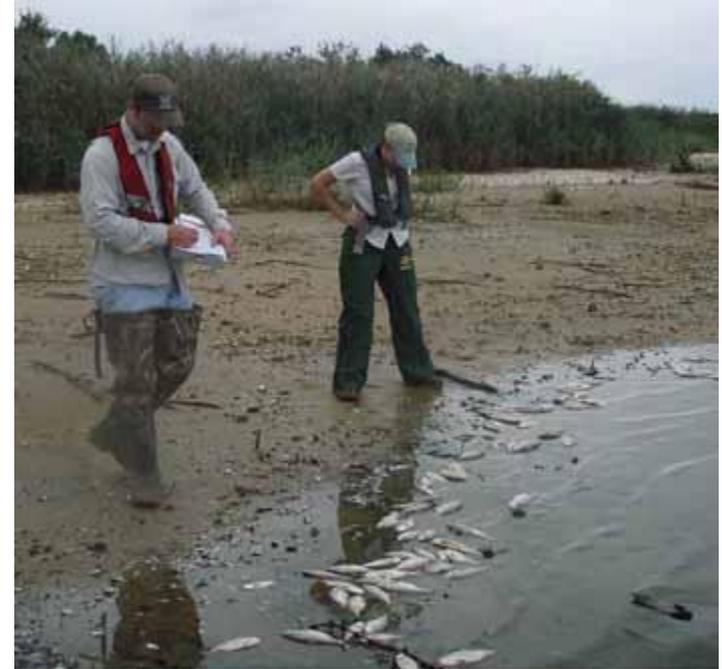
Fish Kill

September 2013

Approx. 25-30 fish died (sun fish and bass) in the City of Woodcreek. The cause seems to be low or no flow in Cypress Creek causing dissolved oxygen levels to drop. Additional stress could also be caused by recent rains stirring up sediment releasing sulfur dioxide into the water column. This combination of high concentrations of sulfur dioxide and low dissolved oxygen most likely caused the fish kill.
