THE MEADOWS CENTER FOR WATER AND THE ENVIRONMENT

CYPRESS CREEK

Cypress Creek Watershed Protection Plan

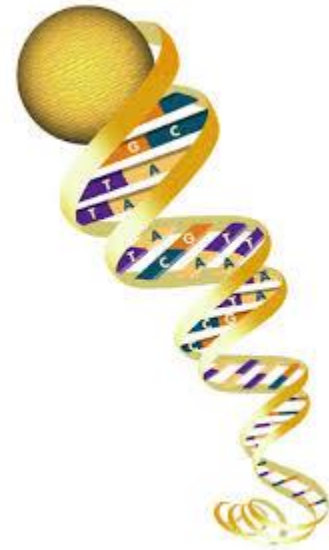
Bacterial Source Tracking – March 2017

- Submitted proposal to Texas Commission on Environmental Quality in 2015 & Texas Soil and Water Conservation board in 2016 to do BST – not funded
- Coordinated with Plum Creek WPP and Texas A&M to combine BST efforts
 - Secured funding and matched funding from Hays County
 - Quality assurance plans for data collection and analyses
 - Professional secondary analyses

- Livestock or wildlife were identified as the source for 90% (18 of 20) of the isolates analyzed by SAML using a 7-way ID.
 - While this does not eliminate other sources, it indicates that livestock and wildlife are a substantial source of *E. coli* bacteria present in this reach of Cypress Creek during both dry and wet weather conditions

- Considerable increases in recorded *E. coli* concentrations noted during each sampling event (both wet and dry weather conditions) moving from upstream Site #1 to downstream Site #2

- Data indicate Site #1 is achieving water quality protective of safe contact recreation during baseflow conditions while *E. coli* concentrations at Site #2 exceeded contact recreation standards during each sampling event

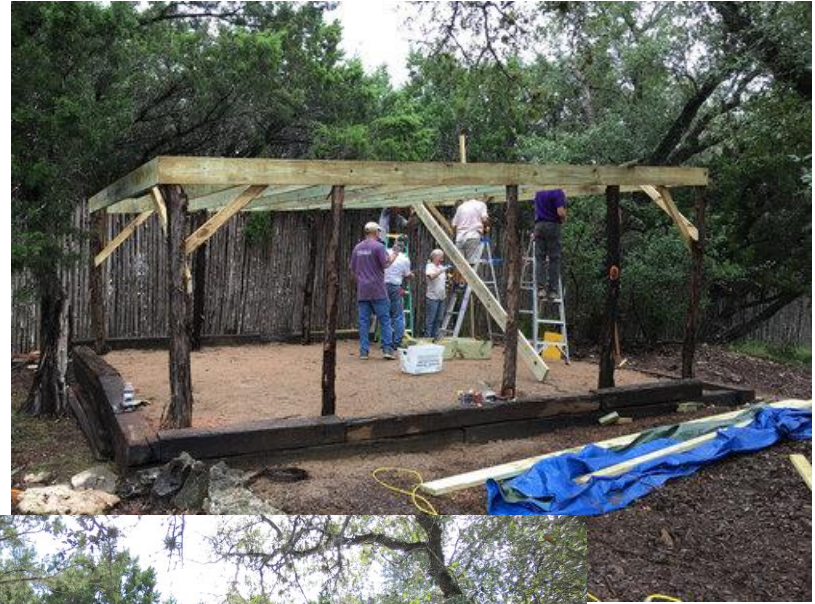
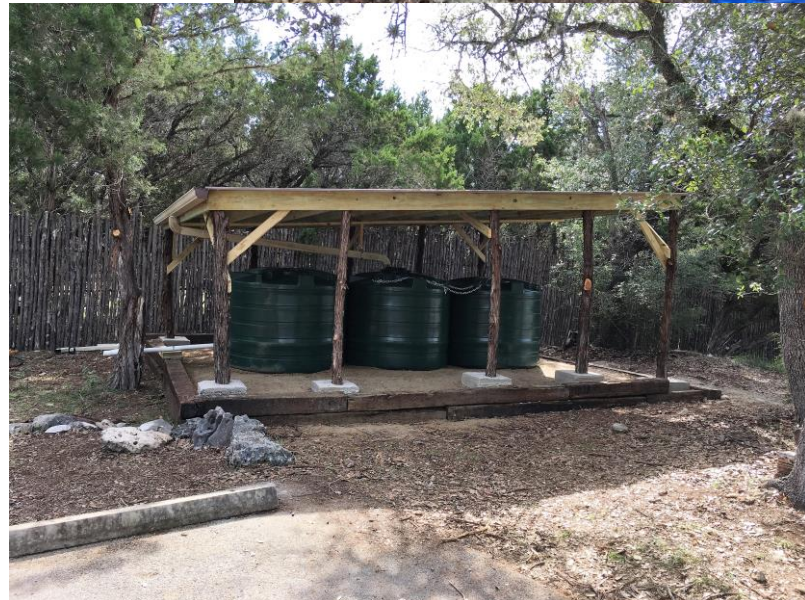
- Demonstration BMPs
 - Rainwater cisterns and rain gardens
 - First BMP installed at the Patsy Glenn Refuge as a demonstration workshop on 10/21/17
 - Partners included the Wimberley Birding Society, Hays County Master Naturalists and the Wimberley Valley Watershed Association
 - <http://www.cypresscreekproject.net/patsy-glenn-rwh-system>
- Biofiltration and Stormwater BMPs coming soon
