GUADALUPE RIVER BASIN

Basin Highlights Report - Spring 2006

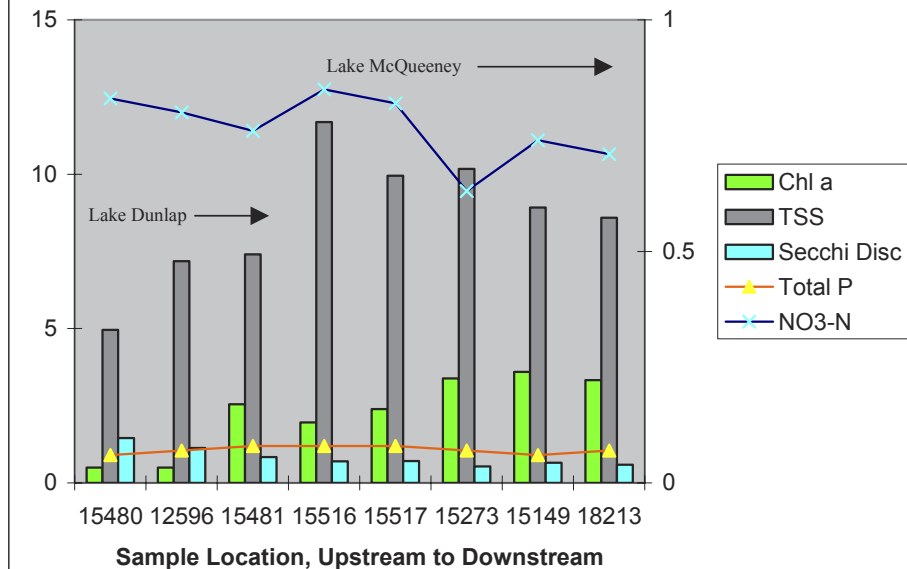
Figure 2. Spatial Distribution of Constituents

A high flow event that occurred in July 2004 showed how concentrations of total phosphorus changed from upstream to downstream during or just following a period of high release rates from Canyon Reservoir. One possible explanation for this rise in phosphorus could be the suspension of dissolved phosphorus associated with sediments by the increased flows. The lack of an associated rise in suspended solids and turbidity would indicate that the phosphorus would be in the dissolved form. A possible source of the dissolved phosphorus could be its release in the low oxygen

A nutrient study was undertaken to determine if there is a spatial relationship as the water moves downstream through Lakes Dunlap and McQueeney, run-of-river impoundments located between New Braunfels and Seguin (Figure 1). Additionally, the study was to determine if the relationship between flow and *chlorophyll a* seen in the historical data was supported in the study period. The study did not clearly identify sources of nutrients, but the spatial analysis of the water quality conditions moving downstream did show nutrient concentrations sufficient to promote algal photosynthetic activity in both reservoirs (Figure 2). Most notably, during the two months that had the most prolonged period of low flow conditions, there was a definite spike in *chlorophyll a* at downstream stations in each impoundment.
