# **Guadalupe-Blanco River Authority 2008 Basin Summary Report**

# Guadalupe River Basin Watersheds

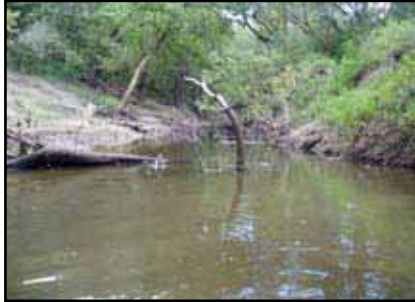
*Inundation and erosion from recent flooding at Peach Creek at CR 353*

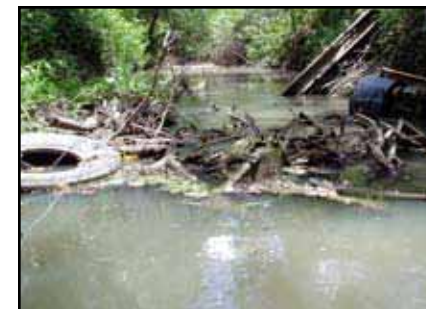
*Illegal dumping in Plum Creek at CR 202*

The biological and habitat assessment was performed on the site on the middle portion of Plum Creek (Plum Creek at CR 202) in 2006. The assessment for 2007 was not completed due to high flow conditions. In 2006, the biological assessment showed that the stream in this location did not support its designated use for aquatic life support. The nekton and habitat IBI scored in the intermediate range and the benthic IBI was limited. As at the other locations in 2006, flow impacted the quality of the habitat which may have resulted in poorer populations of

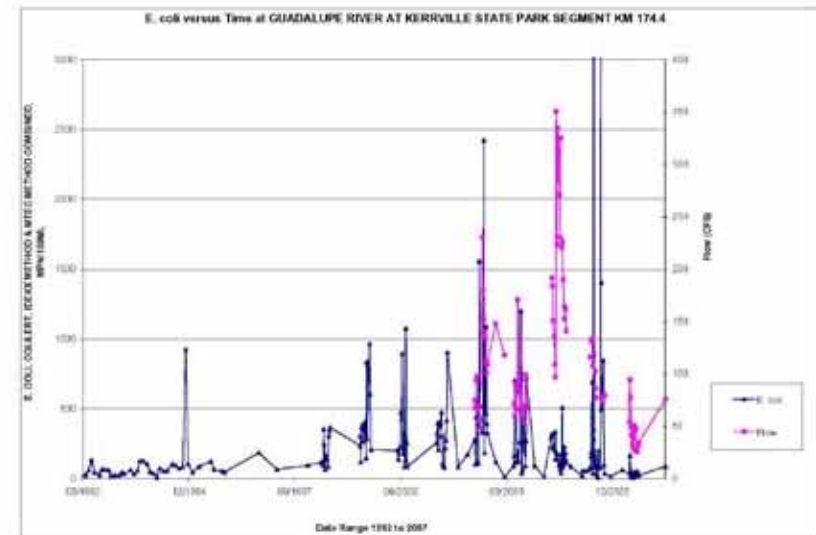
Figure 1. *E. coli* versus time at Kerrville Schreiner Park (12615). In assessment unit 1806\_04.

Segment 1806, the Guadalupe River above Canyon Lake, has been identified by the TCEQ as not supporting designated uses due to elevated *E. coli* bacteria concentrations (figure 2). Due to this concern, a Total Maximum Daily Load (TMDL) study was conducted and subsequently adopted by TCEQ. This TMDL, titled *One Total Maximum Daily Load for Bacteria in the Guadalupe River Above Canyon Lake*, is now a part of the state's Water Quality Management Plan.

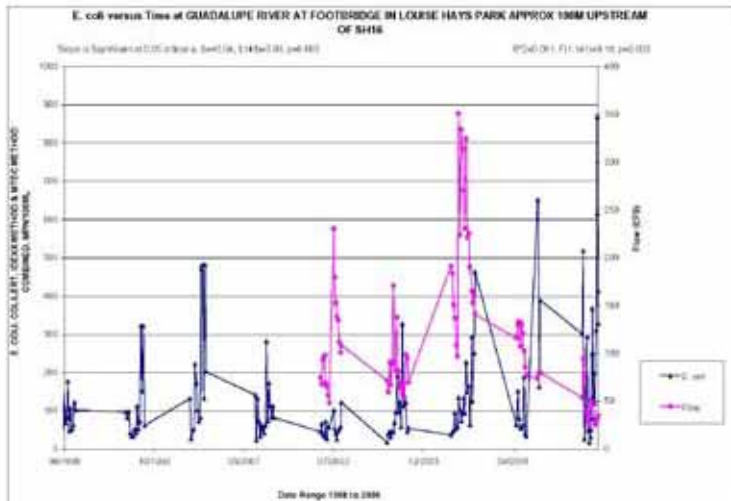
Figure 1. *E. coli* versus time at Louise Hays Park (16243) 100 meters upstream of SH 16, in assessment unit 1806\_06.

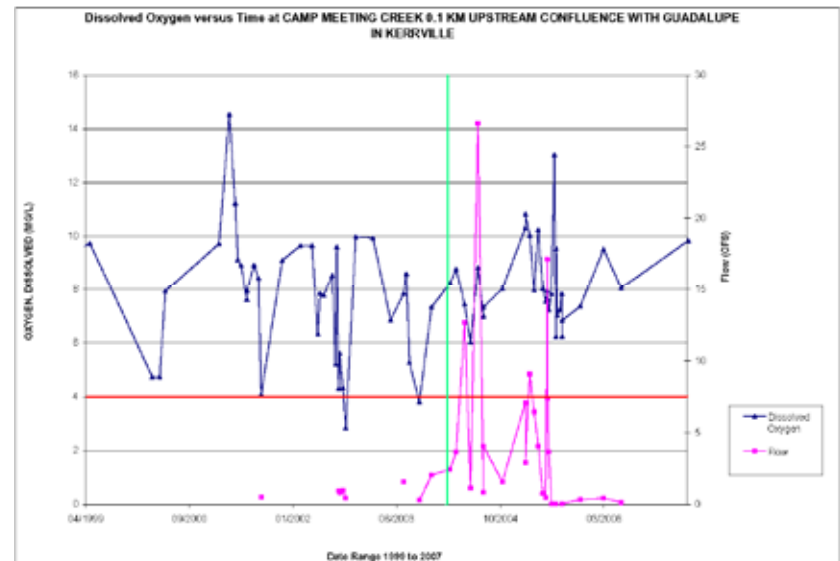
Figure 3. Graph of Dissolved Oxygen versus time at Camp Meeting Creek (12546), 0.1 miles above the confluence with the Guadalupe River. The red horizontal line on the graph represents the single sample standard of 4.0 mg/L of Dissolved Oxygen. The green vertical line on the graph indicates the transition to municipal sewer collection for several of the houses in the upper portion of the watershed.

A review of the data available for station 12546 indicates that water quality in this stream is degraded. The median concentration for dissolved oxygen is 7.9 milligrams per liter (mg/L), ranging from a minimum of 2.8 mg/L to a maximum of 14.5 mg/L. On several occasions during the period of 1998 to the present, the dissolved oxygen values have dropped below the state standard for dissolved oxygen (4 mg/L) (figure 3). The **specific conductance** ranged from 435 to 825 micromhos per centimeter ( $\mu\text{mho/cm}$ ), with a median conductivity of 682

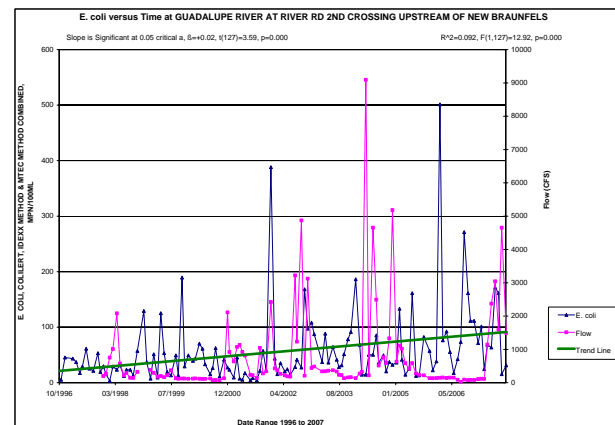
Figure 1. Guadalupe River at 2nd crossing (12658) – *E. coli* versus time all methods.

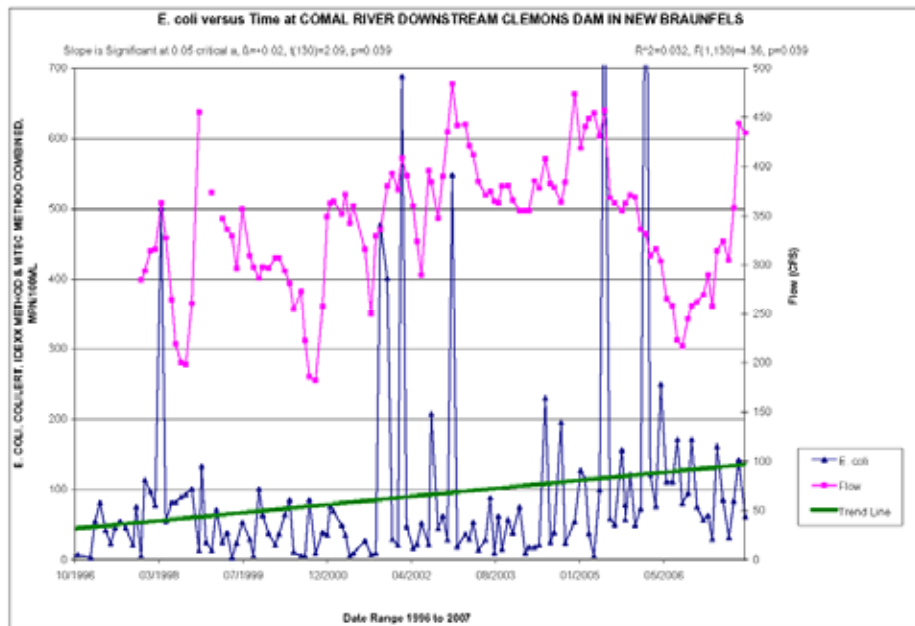
Figure 5. The Hinman Island site (12653) is exhibiting an upward trend in *E. coli* concentration.

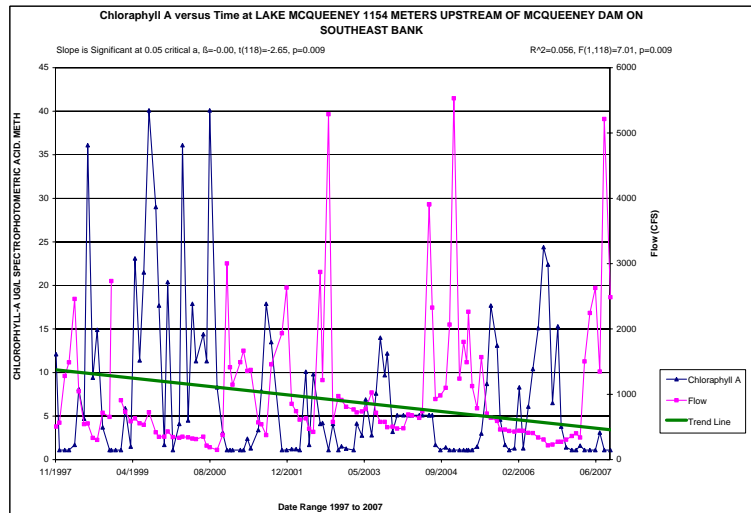
Figure 3. Inverse relationship of chlorophyll a concentration and flow at the GBRA monitoring site on Lake McQueeney (15149).

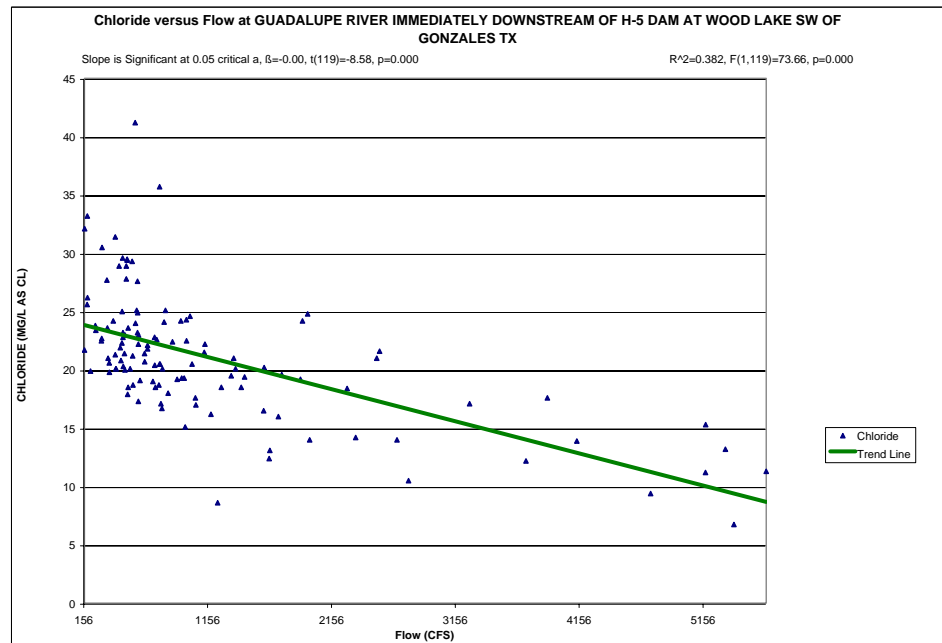
Figure 6. Background chloride concentrations at the GBRA monitoring site located at the Guadalupe River at H-5 (15110) are diluted with high river flows.

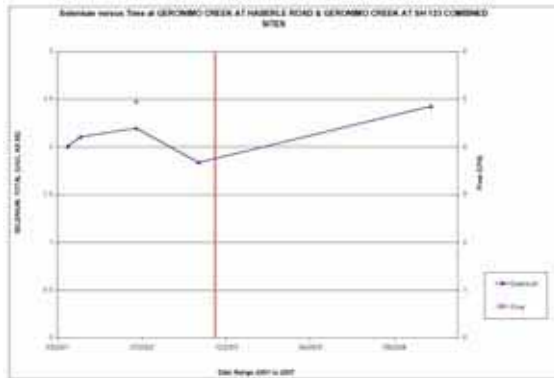
Figure 2. Selenium versus time at the combined Geronimo Creek at SH 123 (14932) and Haberle Road (12576) stations. The vertical red line represents the transition from the SH 123 station to the Haberle Road station.

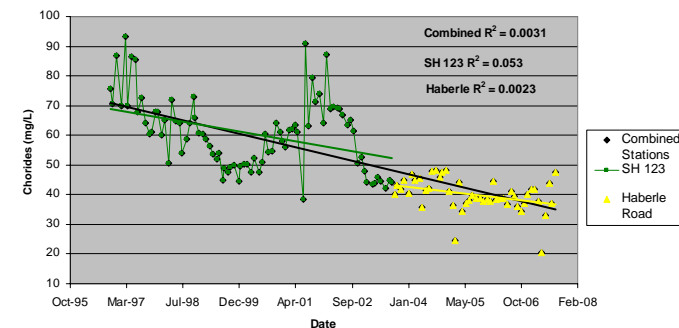
Figure 5. Chloride versus time at the combined Geronimo Creek at SH 123 (14932) and Haberle Road (12576) station.

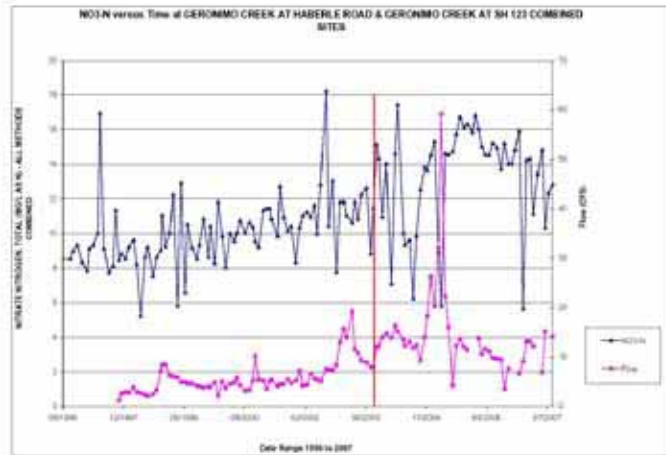
Figure 6. Nitrate nitrogen versus time at the combined Geronimo Creek at SH 123 (14932) and Haberle Road (12576) stations. The vertical red line represents the transition from the SH 123 (14932) and Haberle Road (12576) station.

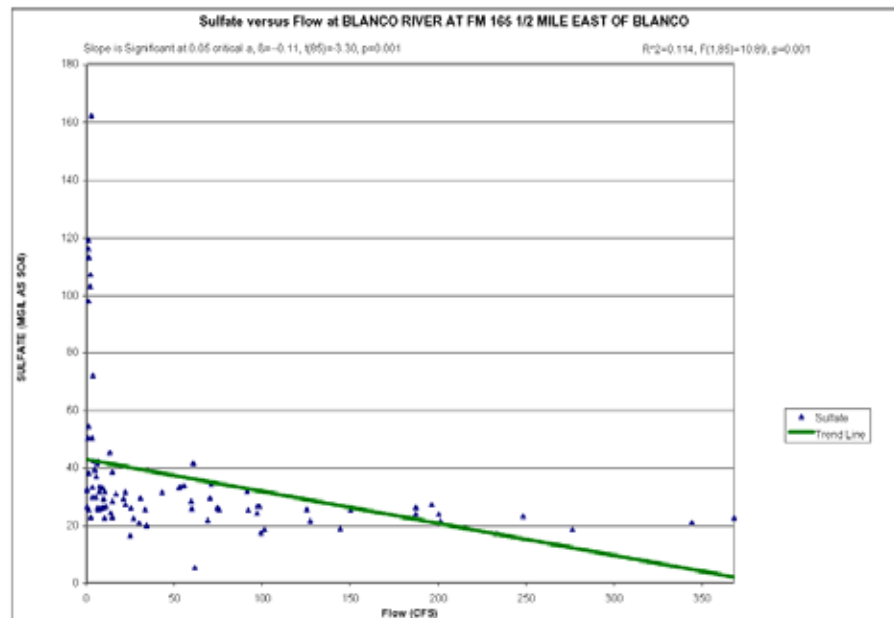
Figure 4. Sulfate concentration versus Flow at the Blanco River at FM 165 (12668) GBRA Monitoring Station. An inverse relationship was found to exist between sulfate and flow.

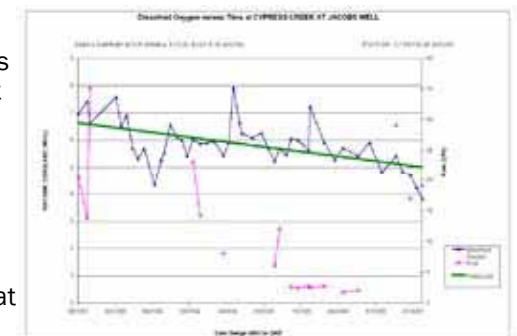
Figure 1. Dissolved oxygen over time at Jacob's Well (12677) on the Cypress Creek.

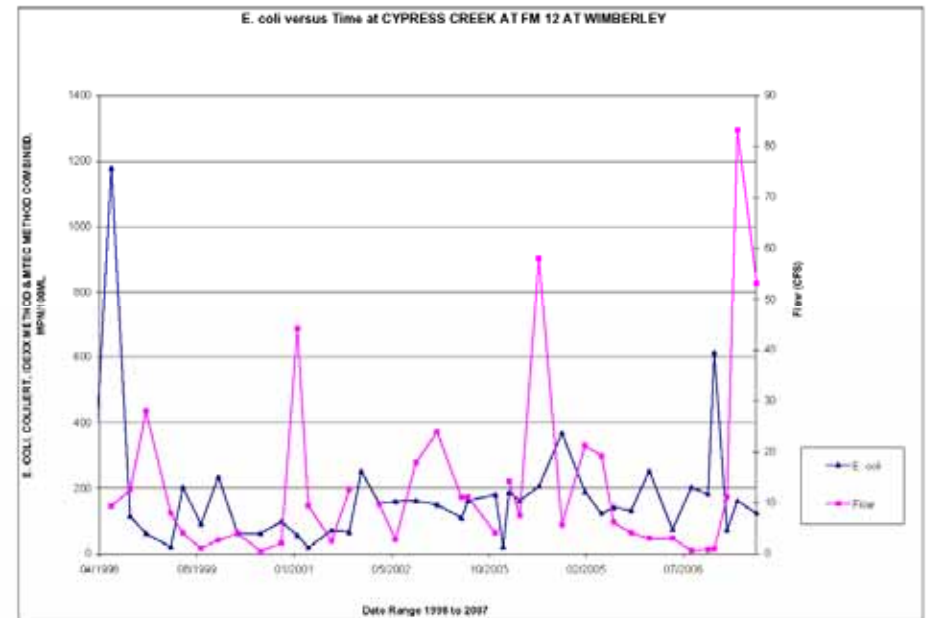
Figure 2. *E. coli* concentrations and flow over time at the Cypress Creek at FM 12 site (12674).

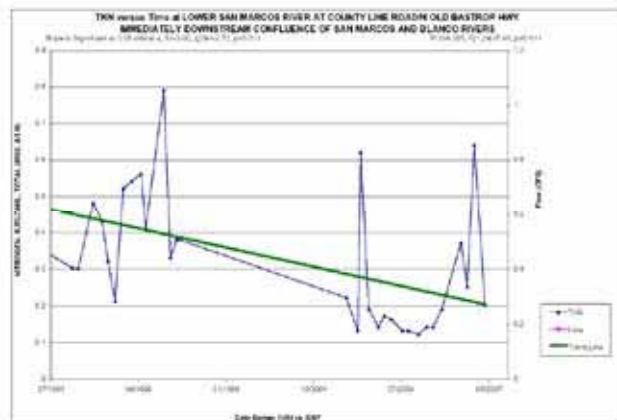
Figure 4. Total Kjeldahl Nitrogen versus time at the San Marcos River at Old Bastrop Highway (12628) (No flow data was available for this data set).

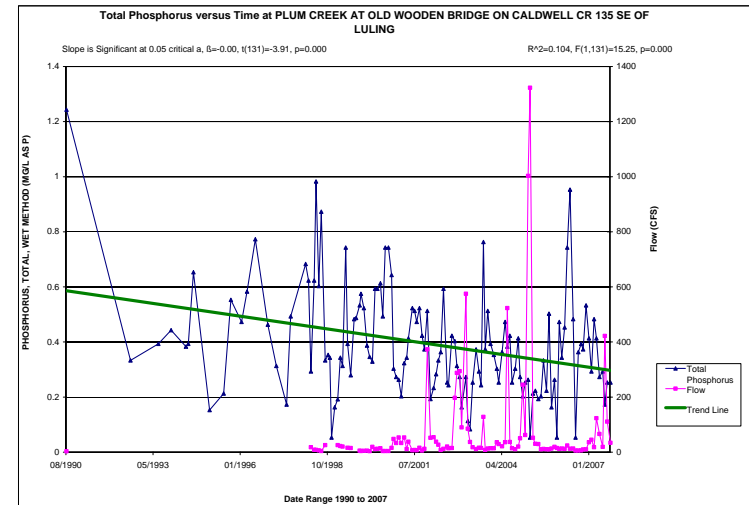
Figure 7. Data at the GBRA monitoring site at CR 135 (12640) shows a significant downward trend in total phosphorus over time that could be explained by an increase in frequency in analyses in the later years of historical monitoring.

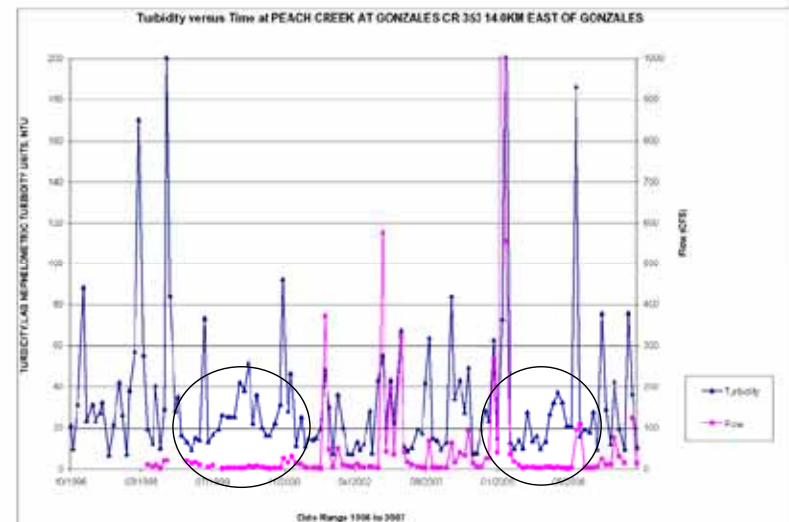
Figure 3. Turbidity and Flow over the period of historical data at the GBRA monitoring site at CR 353 (14937).

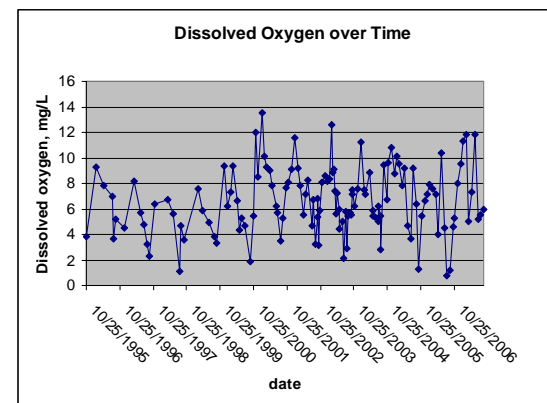
Figure 1. Dissolved oxygen concentrations measured over time in Sandies Creek at Westhoff (13657).

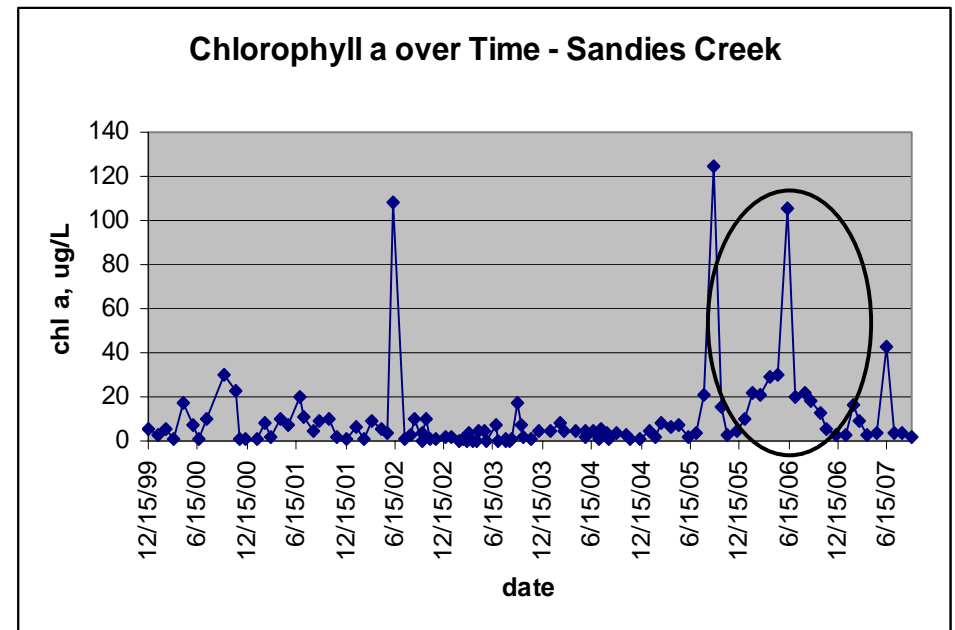
Figure 4. Chlorophyll a concentrations increase during low flow periods at the Sandies Creek at Westhoff (13657) as seen in 2006.

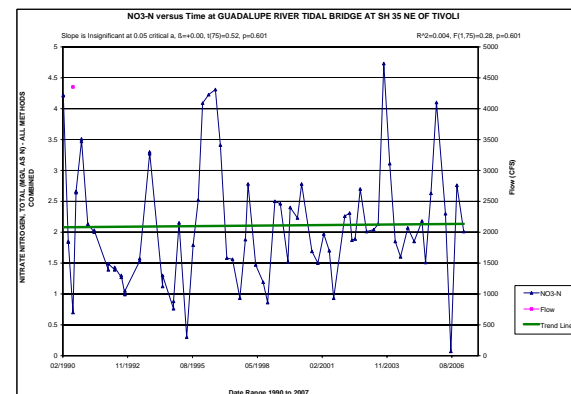
Figure 1. Guadalupe River at Tidal Bridge (12577)– nitrate nitrogen over time.

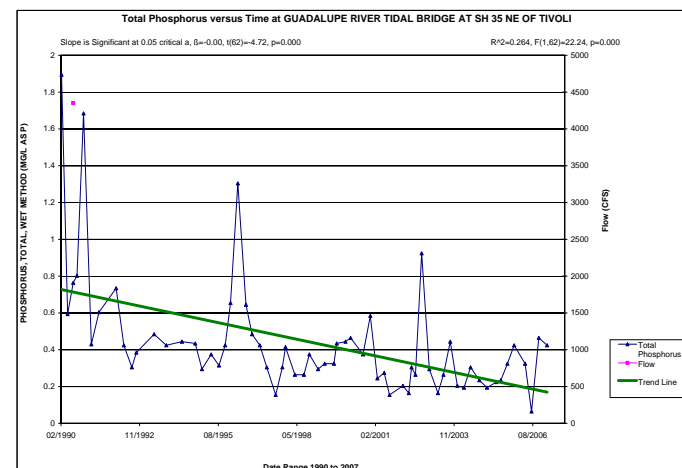
Figure 2. Guadalupe River at Tidal Bridge (12577) – phosphorus concentrations showing slight decline over time.

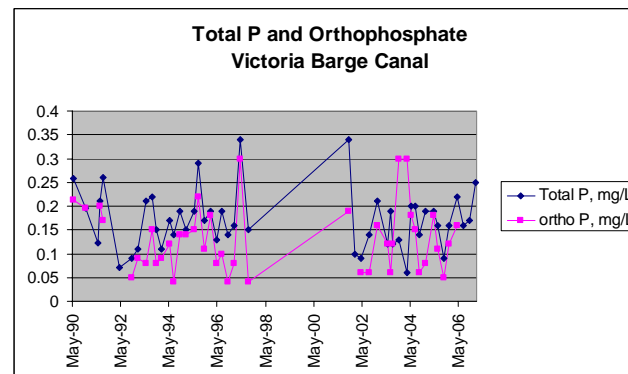
Figure 2. Total and orthophosphate concentrations in Victoria Barge Canal (12536).
