### Monitoring Stations -Middle Guadalupe River Watershed Part A

# Middle Guadalupe Watershed (Part A)

# Middle Guadalupe Watershed (Part B)

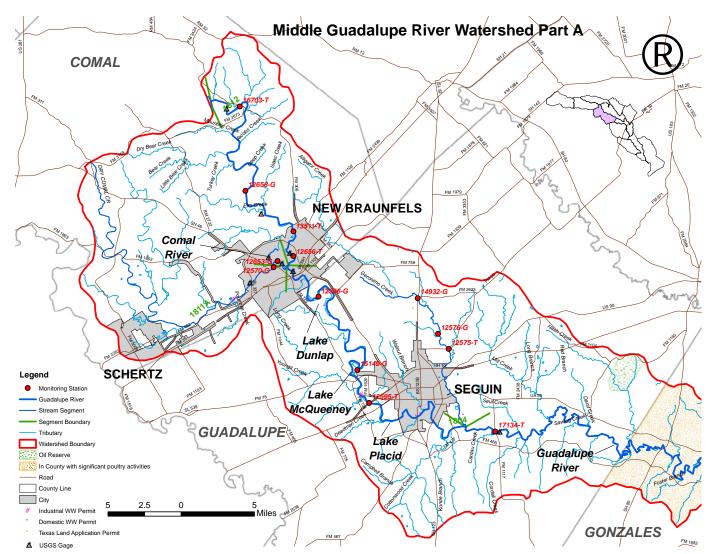
16703-T Guadalupe River at FM 306, downstream of Horseshoe Falls 12658-G Guadalupe River at Second Crossing 13511-T Guadalupe River at Gruene Bridge 12656-T Guadalupe River at Cypress Bend Park in New Braunfels 12653-G Comal River downstream Clemons Dam (Hinman Island) 12570-G Dry Comal Creek at Missouri-Kansas Railroad Crossing 12596-G Lake Dunlap at AC's Place 15149-G Lake McQueeney near the dam at Hot Shots 12595-T Guadalupe River at IH 10 (Lake Placid) 14932-G Geronimo Creek at SH 123 12576-G Geronimo Creek at Haberle Road 12575-T Geronimo Creek at FM 20 17134-T Guadalupe River at FM 1117

Sampling sites are labeled in red followed by the letter G (GBRA), T (TCEQ), U (UGRA) or W (Wimberley) indicating who is the monitoring entity.
