# **2018** *Clean Rivers Program* **Basin Summary Report**

## **Guadalupe River and Lavaca-Guadalupe Coastal Basins**

A summary of the monitoring and watershed protection activities, and water quality conditions of the watersheds in the Guadalupe River and Lavaca-Guadalupe Coastal Basins.

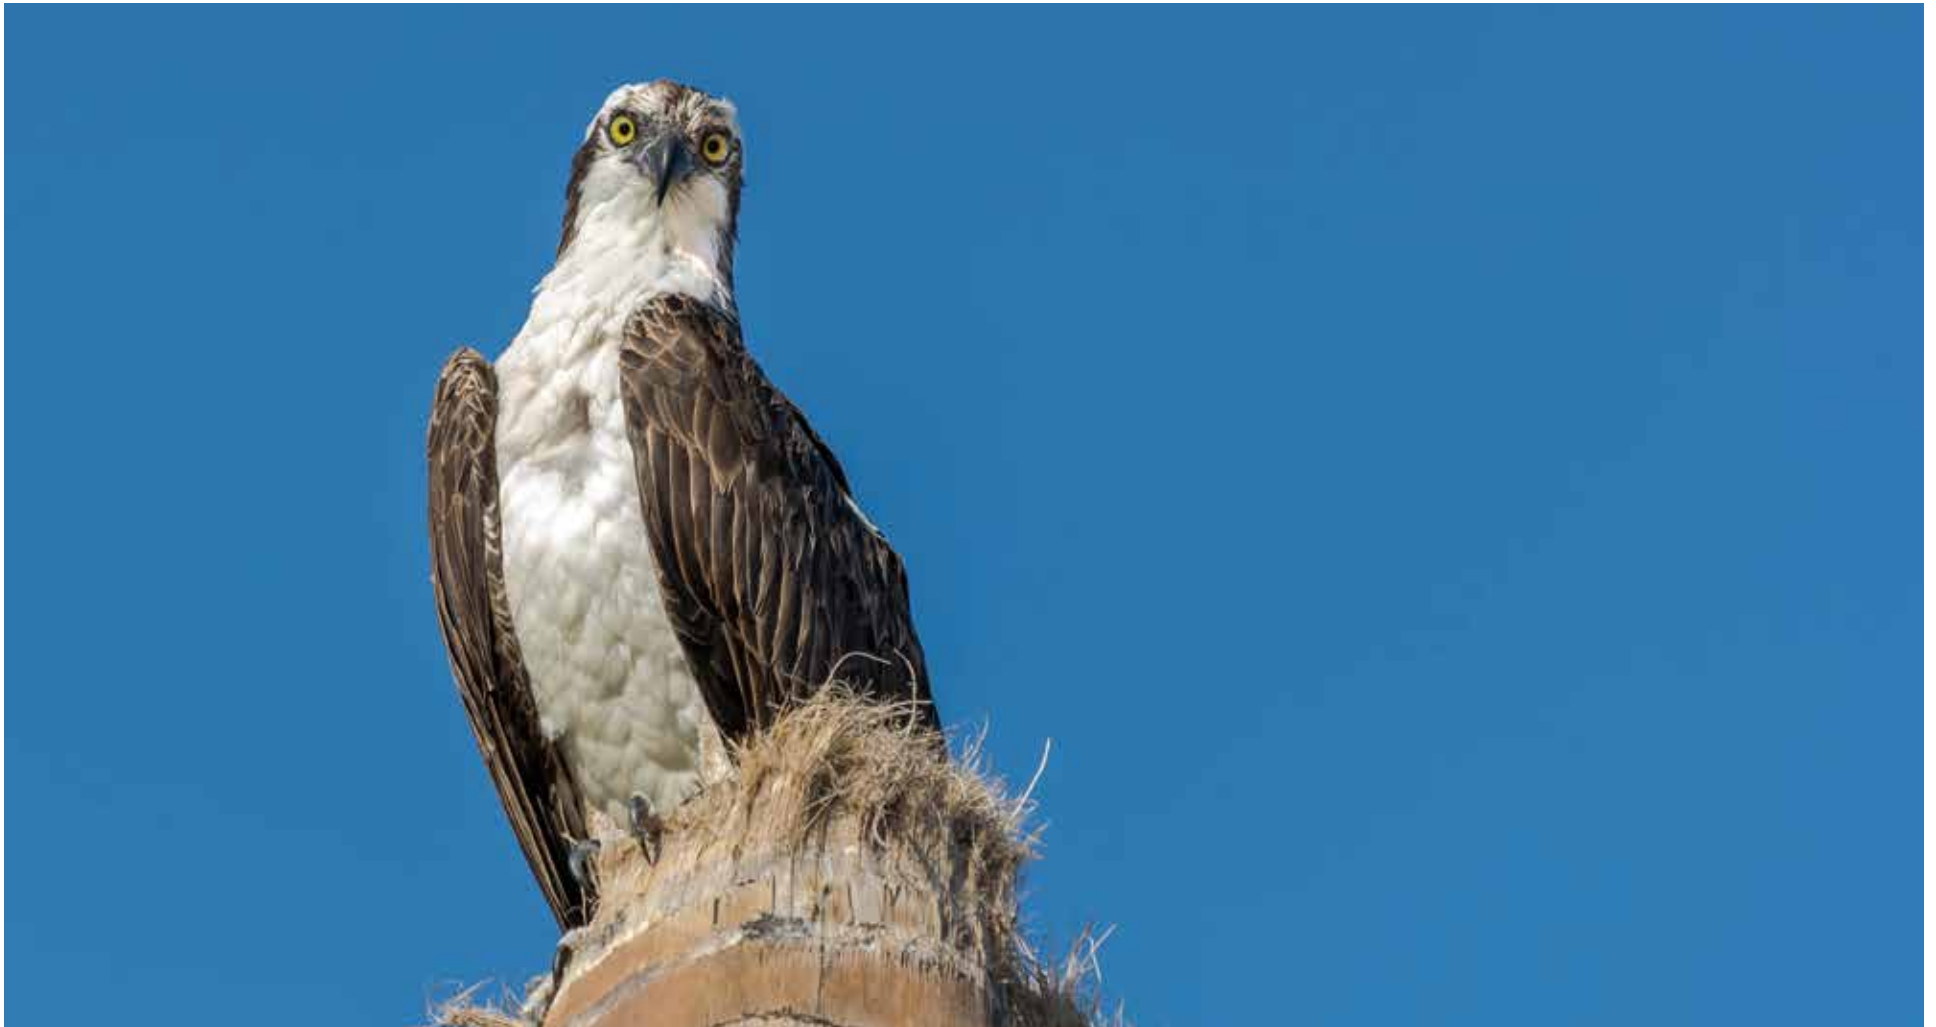
a significant change over time at this station was chloride, which is significantly increasing (Figure 1). The increasing level of chlorides is mostly likely due to the influence of several years of drought that began 2008. During this time period, fresh water inflows were reduced and salts became more concentrated in the water column. The average chloride concentration of 16.8 mg/L remains well below the state screening criteria of 50.0 mg/L.

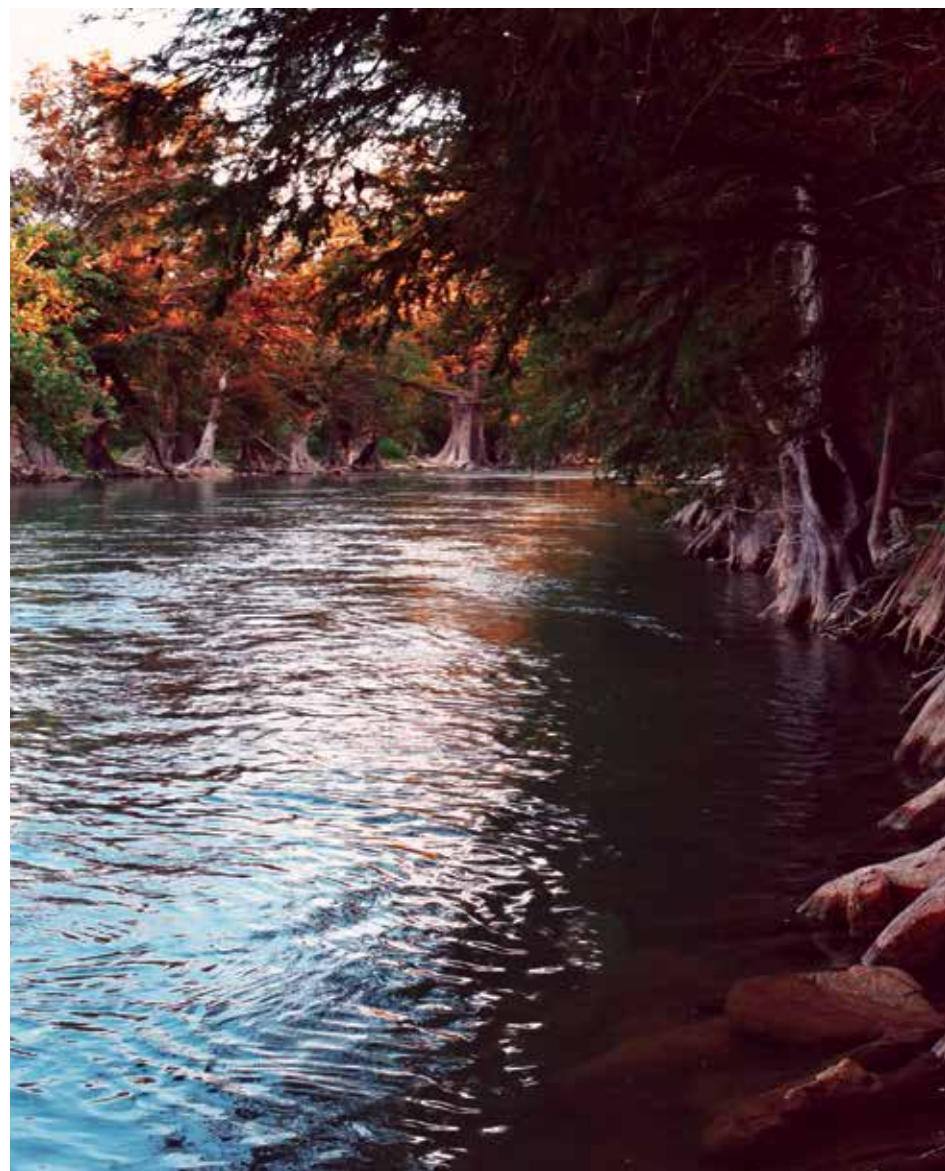
because of its proximity to the releases of Canyon Dam. chloride and sulfate levels were both significantly increasing over time at station 16703 (Figures 1 &

2). The increased concentrations in salt anions may be due to diminished stream flow as a result of years of drought, but no statistically significant correlation was found between these parameters and stream flow.

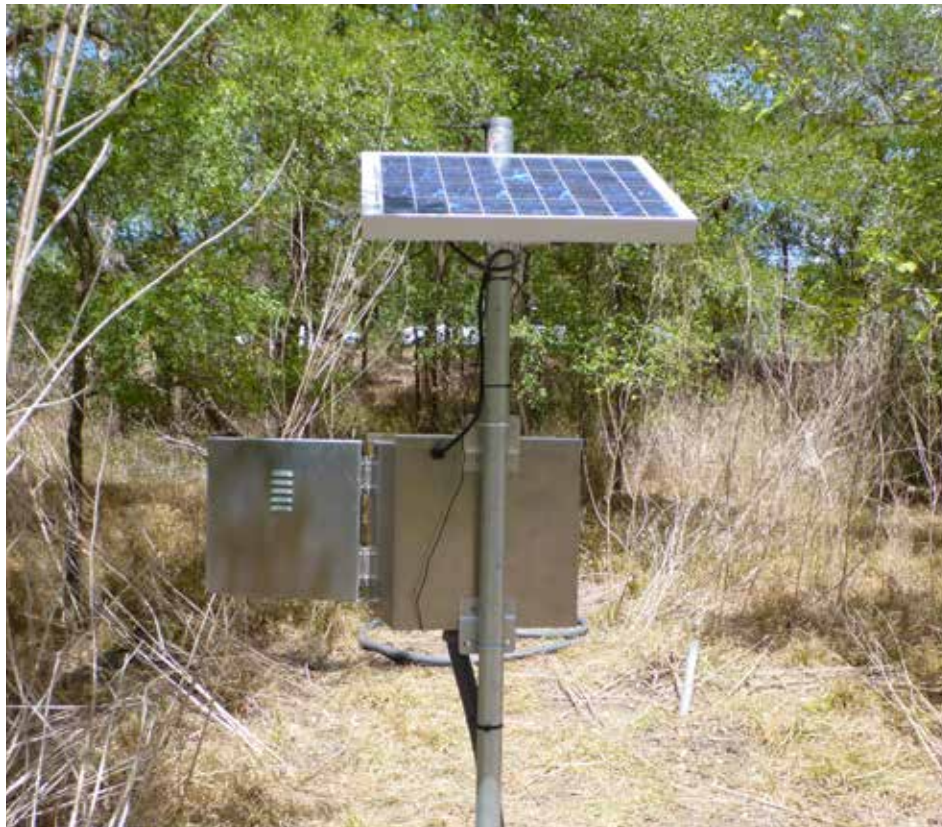
Figure 1

noted two trends in water quality. The dissolved oxygen concentrations and the total hardness concentrations at this station are both significantly decreasing over time (Figures 1 & 2). Although no direct correlation with stream flow was discovered, both of these parameters may have been decreasing due to the stagnant conditions resulting from several prolonged years of drought in the watershed.
