GUADALUPE RIVER ABOVE FLAT ROCK DAM

Guadalupe River Above Flat Rock Dam Watershed Summary

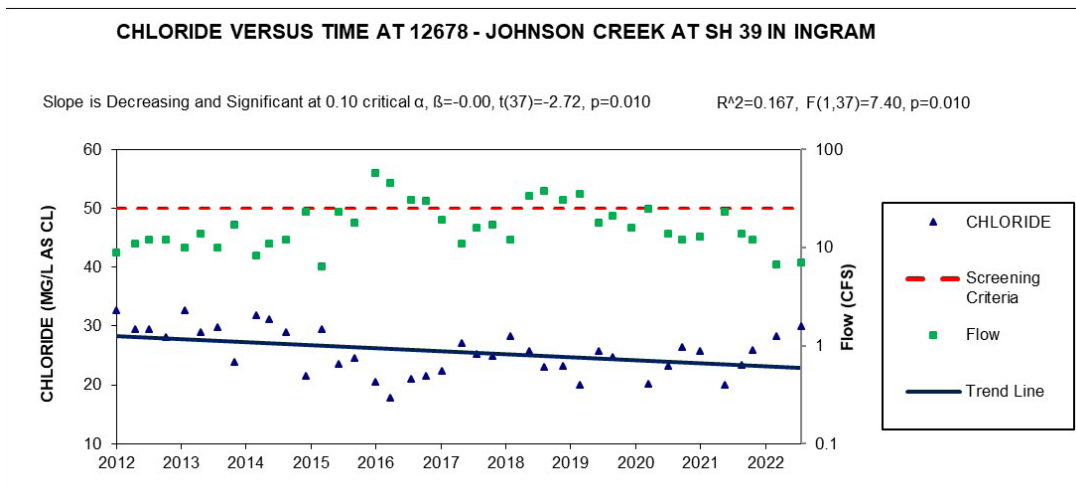
Figure 2: Chloride trend at Station 12678

Data analysis from segment 1816 showed that chloride is significantly decreasing and the trend is significantly correlated with flow. Rainfall was below average during the 10-year period of this analysis; decreased runoff could be contributing to this decrease.

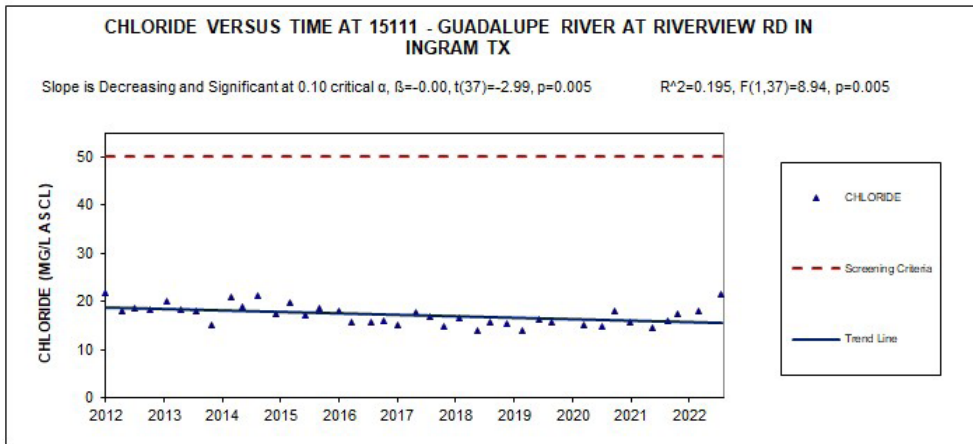
Figure 3: Chloride trend at Station 15111

Data analyses indicated that chloride levels significantly decreased over time at multiple sites throughout this segment. Chloride data from station 15111 is shown here (Figure 3). Analyses also showed decreasing sulfate (Figure 4) and nitrate (Figure 5) levels at station 12546. This could be due to annual rainfall amounts during the ten-year period which were mostly below average, leading to decreased surface runoff and reduced chloride and sulfate loading. Communities around Center Point in Kerr County recently transitioned from private septic systems to a public collection system for wastewater, which could also help reduce chloride, sulfate, and nitrate levels.
