COLETO CREEK

Segment 1807 - Coleta Creek

Table 26: Summary of the 2022 Texas Integrated Report / Segment 1807

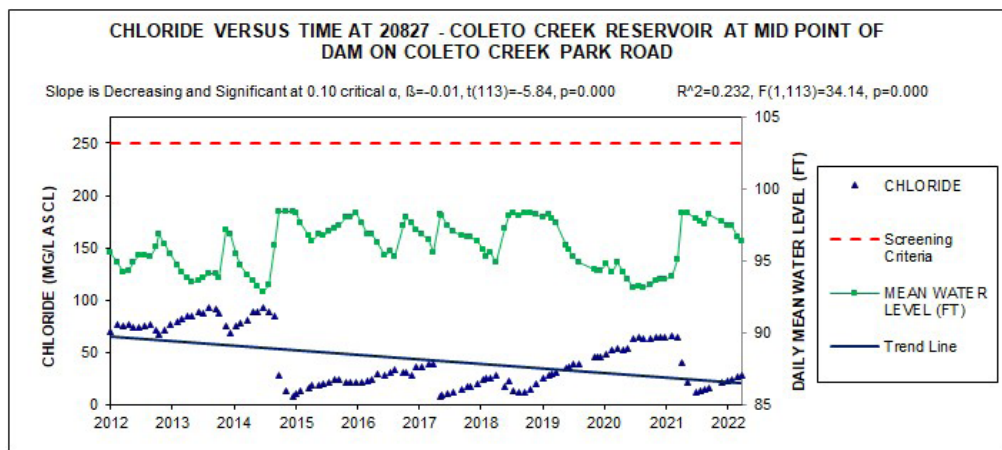
Figure 50: Chloride trend at Station 20872

Decreasing trends were seen for chloride (Figure 50) and sulfate (Figure 51) over time in this segment. These trends are significantly correlated to the reservoir stage; as stage increases, chloride and sulfate decrease. A cyclical trend in stage height is seen in the reservoir with the lowest stage typically observed in the summer and highest stage seen in the winter.

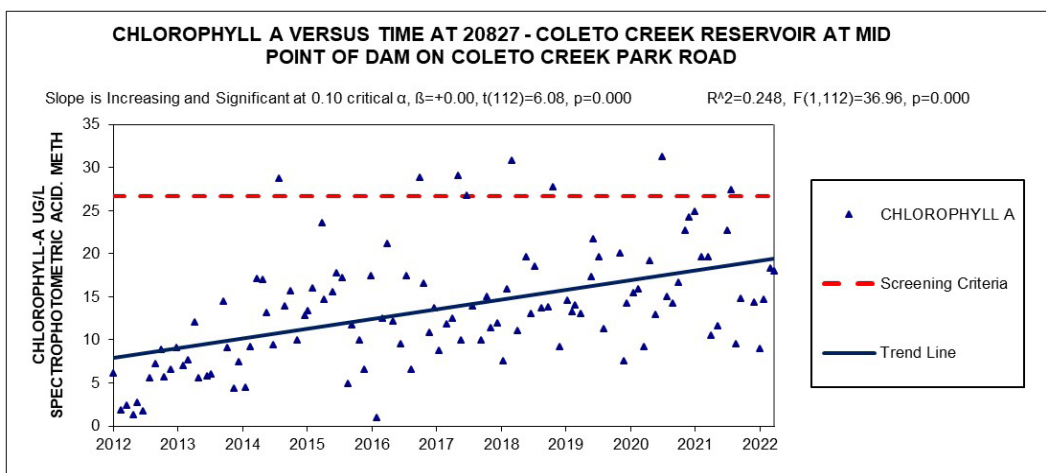
Figure 52: Chlorophyll a trend at Station 20872

An increasing trend for chlorophyll a (Figure 52) was identified at this station. The trend could be linked to increased nutrient loading from the surrounding rural watershed.
