2023 BASIN SUMMARY REPORT

Clean Rivers Program

Guadalupe River and Lavaca-Guadalupe
Coastal Basins

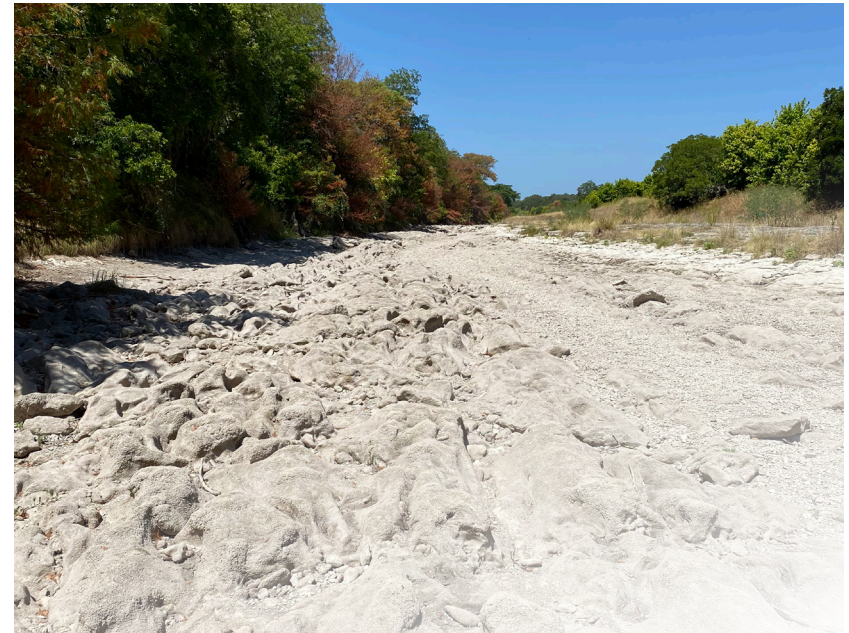
Photo 1: Dry Guadalupe River Bed at RR 311 Near Spring Branch

has been more extreme and less predictable than in previous decades. According to the National Oceanic and Atmospheric Administration (NOAA), 2015 was the wettest year on record in New Braunfels; the area received 43.45 inches of rain while the annual average is 34.95 inches. 2022 was the driest year on record for the same area; only 14.26 inches of rain fell. Though rainfall has increased in recent months, as of the time of this report most of the Guadalupe River Basin is still under drought conditions (Figure 1). The headwaters and upper portion of the basin are currently under extreme to exceptional drought; the Guadalupe River directly above Canyon Lake went dry for several months during 2022 (Photo 1).

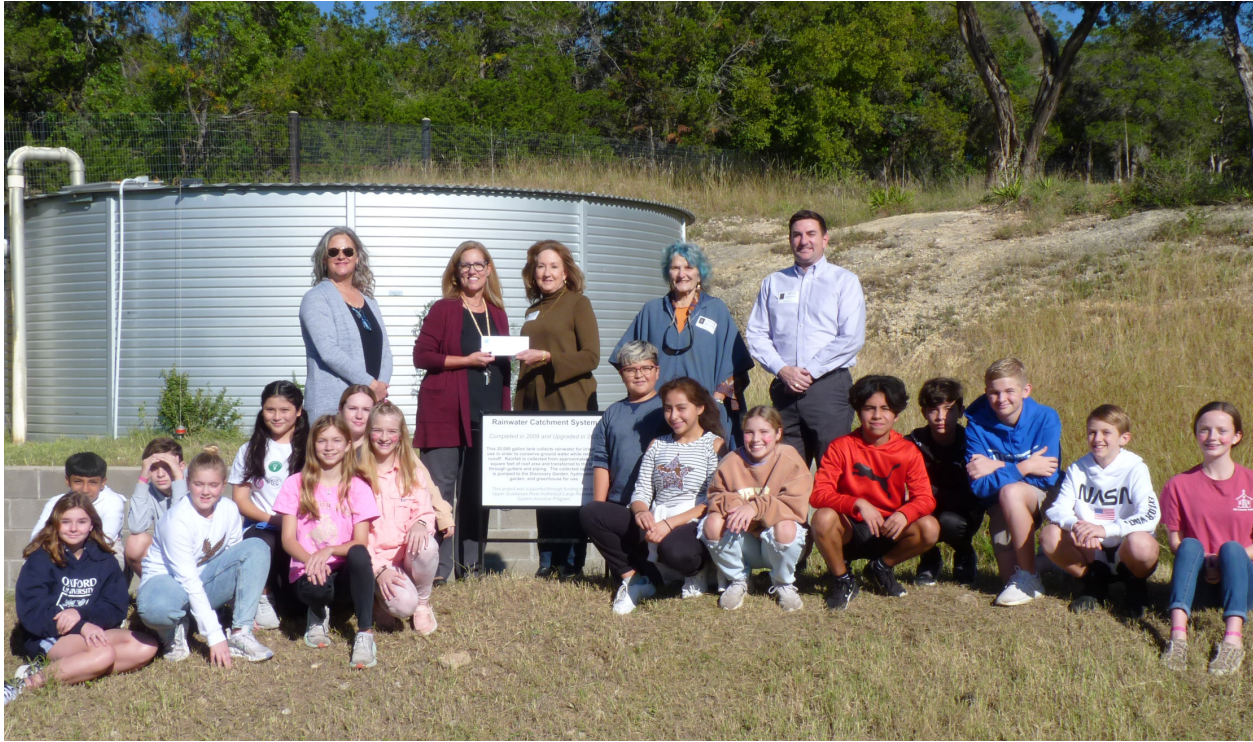
Photo 2: Hunt School Receiving Funds for Rainwater Catchment System

stormwater runoff, UGRA encourages the practice of rainwater harvesting by offering a rebate up to \$500 on the purchase of rainwater harvesting equipment. In 2022, UGRA launched the Rainwater System Grant Program to promote the construction of higher capacity rainwater catchment systems by nonprofit organizations, schools, and public entities (Photo 2). UGRA is also preparing to introduce a rebate program to incentivize local use of low impact development strategies to manage stormwater runoff.

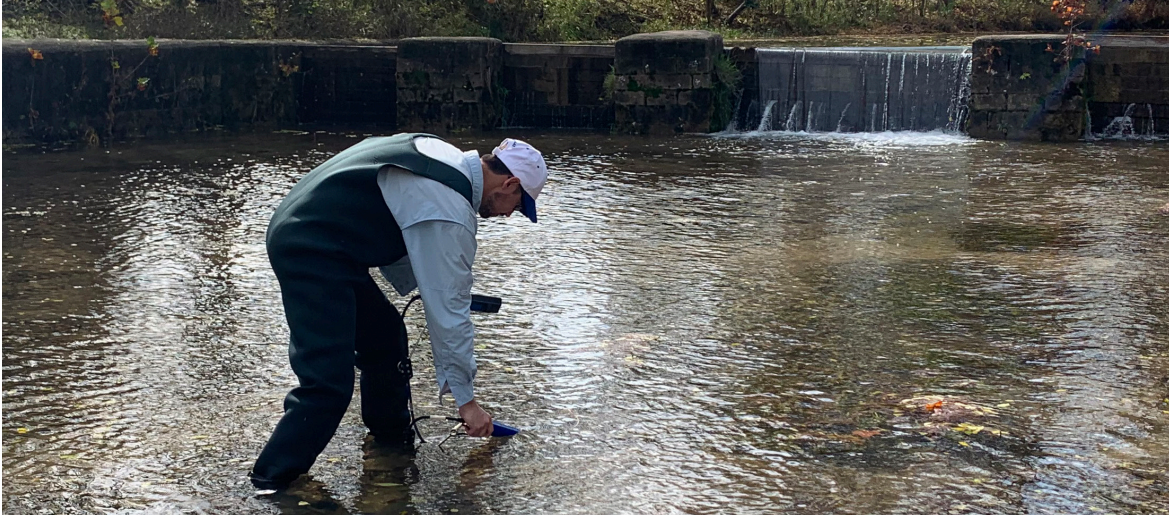
Photo 4: Monitoring Water Quality Near a Low-Head Dam in the South Fork Guadalupe River at Hunt Crossing

and cool, clear rivers in the area have led to an increase in population and urban sprawl over the years. Swimming, fishing, and kayaking are popular in this watershed. Additionally, there are several summer camps along the banks of the streams throughout this watershed. Many of these camps have low-head dams (Photo 4) on the river near their property that create swimming holes for the campers.

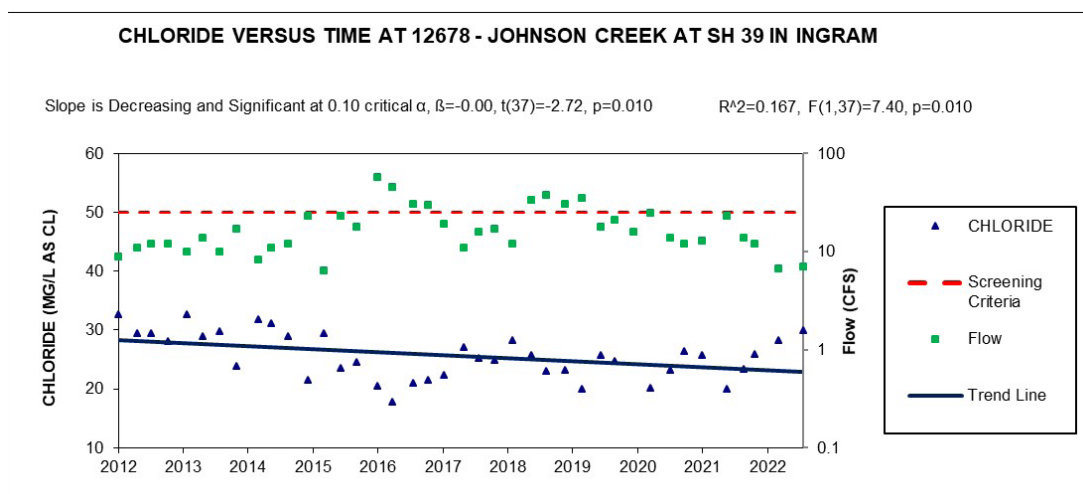
Figure 2: Chloride trend at Station 12678

Data analysis from segment 1816 showed that chloride is significantly decreasing and the trend is significantly correlated with flow. Rainfall was below average during the 10-year period of this analysis; decreased runoff could be contributing to this decrease.

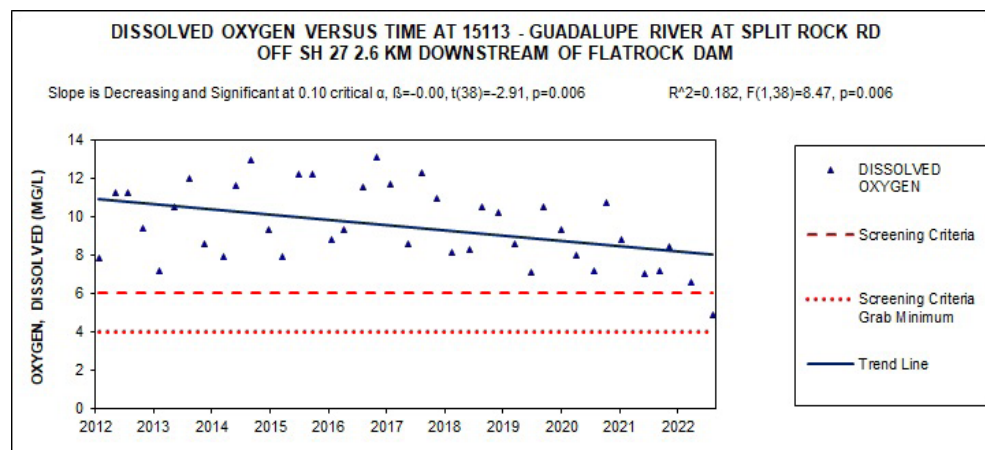
Figure 10: Dissolved oxygen trend at Station 15113

At station 15113, a decreasing trend for dissolved oxygen was identified, and E. coli, though still below the screening criteria, had an increasing trend. Both of these trends are likely due to the drought conditions and change in rainfall patterns.

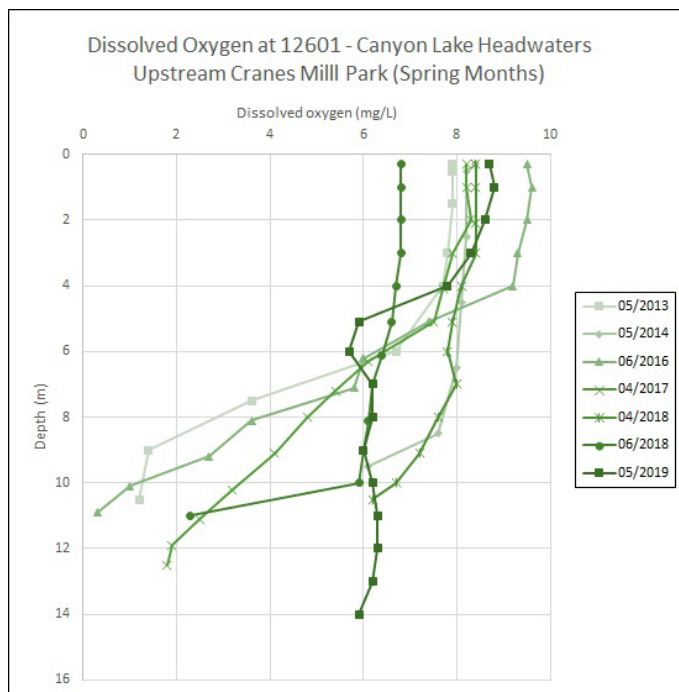
Figure 12: Spring DO at Station 12601

Canyon Lake is monomitic, meaning it experiences one thermal stratification event each year. During the winter months, temperatures throughout the entire depth of the lake are consistent; in the summer months, the lake becomes thermally stratified with a noticeable thermocline between 8 to 10 meters down. When the lake is stratified, water in the epilimnion, or upper layer, becomes warmer and less dense and is unable to mix with the water in the hypolimnion, or lower layer, which is colder and denser. Water in the hypolimnion also tends to become anoxic as organic matter is broken down by bacteria, depleting the available dissolved oxygen. This decline in dissolved oxygen below the thermocline is observed at all monitoring stations in Canyon Lake, trends from station 12601 are shown on the next page:

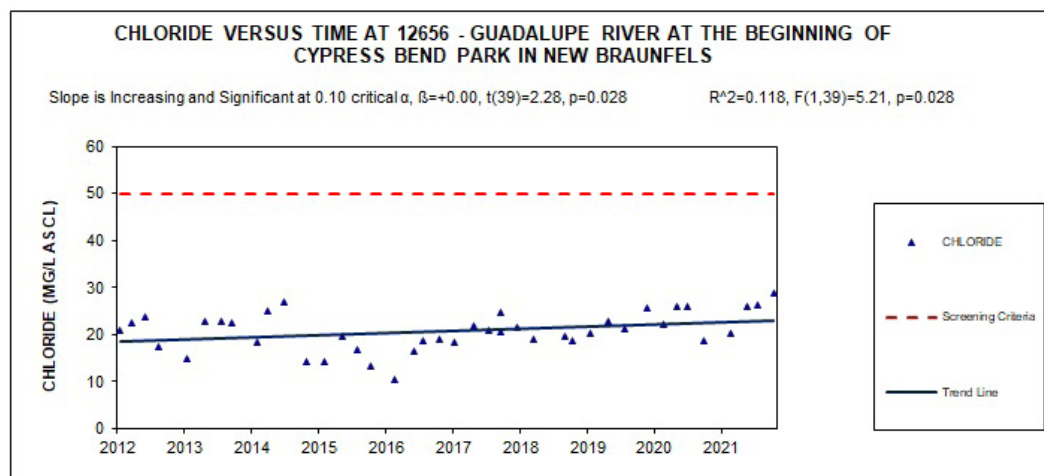
Figure 15: Chloride trend at Station 12656

At Station 12656, chloride levels show an increasing trend. Increased chlorides can be a result of diminished flow.

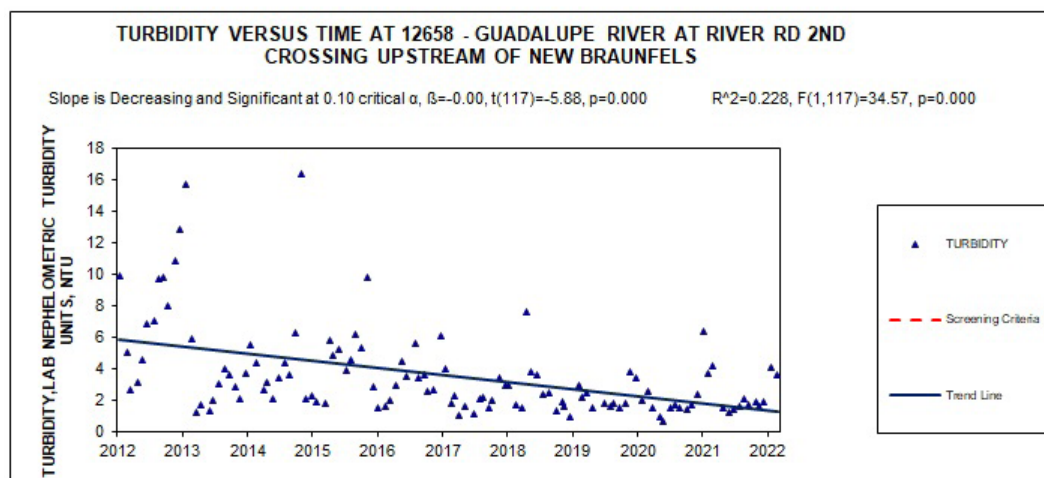
Figure 16: Turbidity trend at Station 12658

Data analysis at Station 12658 show a significantly decreasing trend in turbidity over the reported period. Segment 1812, and Canyon Reservoir which is immediately upstream, are known for having generally low turbidity. In 2017, it was confirmed that the invasive species zebra mussels had been accidentally introduced to Canyon Reservoir. Zebra mussels are highly efficient filter feeders and have further reduced the turbidity and levels of total suspended solids (TSS) in the reservoir. This likely contributes to the reduced turbidity levels at Station 12658.

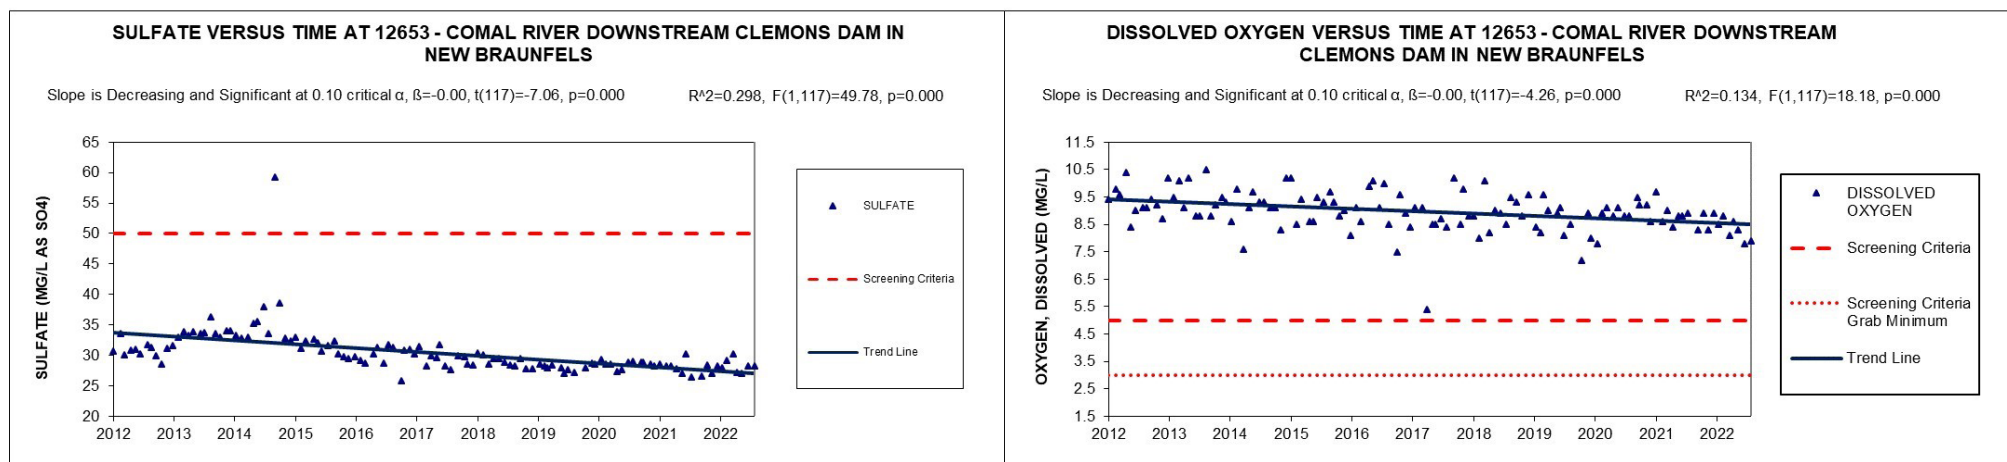
Figure 17: Sulfate trend at Station 12653

Trend analyses performed at station 12653 showed a decreasing trend in sulfate over time (Figure 17), which is inversely correlated with flow. Improving flow rates following the end of the drought of 2011 could be a contributing factor to the decrease.

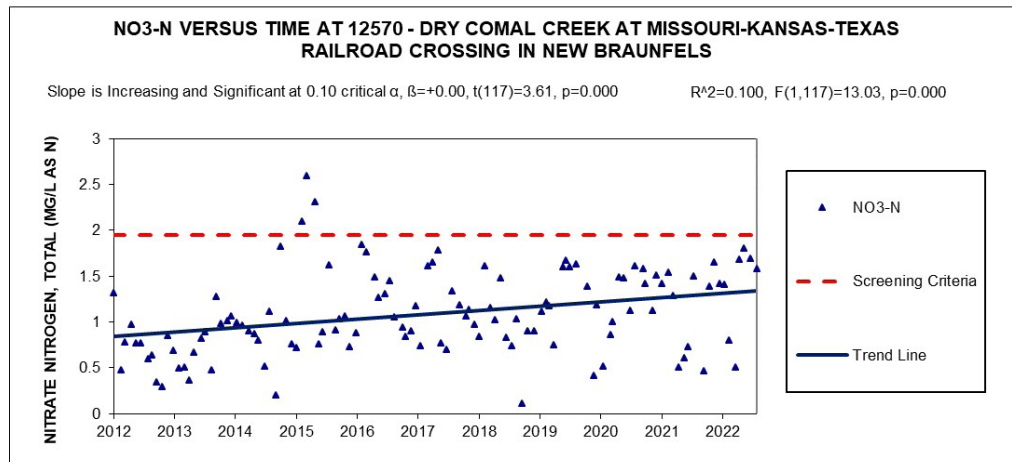
Figure 19: Nitrate trend at Station 12570

At station 12570 (1811A), data analysis shows that nitrate is significantly increasing (Figure 19), which could be due to increased non-point source runoff from agriculture in the watershed.

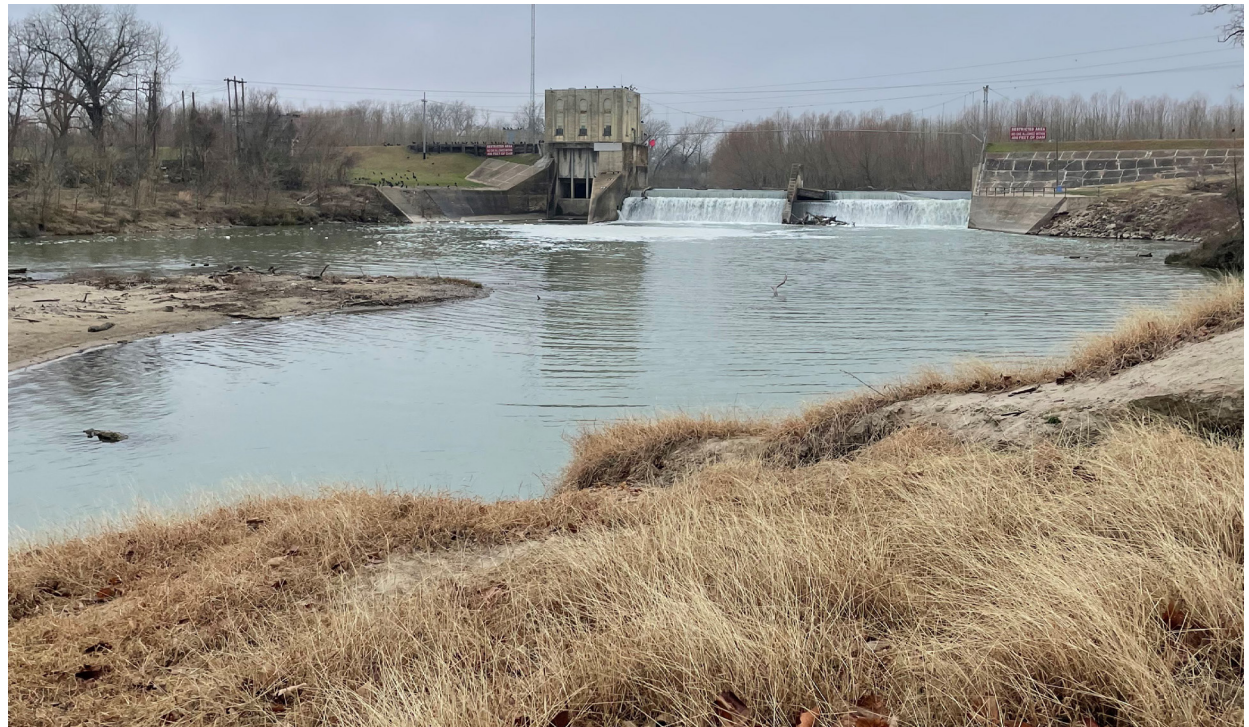
Guadalupe River at H5 Dam

This segment experiences a 300-foot drop in elevation as it flows south. This elevation change created an ideal location for the construction of six hydroelectric dams to provide power to the surrounding area. The dams were constructed in the 1920s to 1930s and GBRA took ownership in 1963. Unlike Canyon Dam, which is a flood control structure, these are pass-through dams that do not control flood waters. Because of the relatively high velocity of the water flowing through these impoundments (referred to collectively as the Guadalupe Valley Lakes), water quality is significantly different than in larger reservoirs. Stratification, which occurs in Canyon Reservoir, does not occur in these impoundments. Recreation including boating, fishing, and water skiing are extremely popular on the Guadalupe Valley Lakes. The land surrounding Lake Dunlap, Lake McQueeney, and Lake Placid is urban and located in the rapidly expanding I-35 corridor. The watershed surrounding the lower three lakes is more rural. Over time as the dam structures have aged, they have exceeded their useful life expectancy period and are no longer structurally sound. In recent years, several of the structures have failed despite regular maintenance, and replacement of several of the dams is taking place.

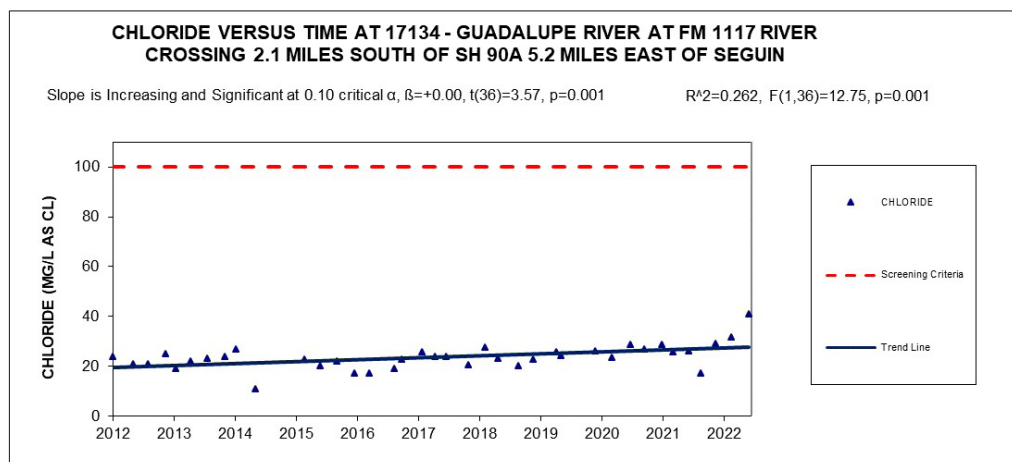
Figure 21: Chloride trend at Station 17134

At station 17134, increasing trends were found for chloride and sulfate. These trends do not have a strong correlation with flow and it is unknown why these trends are increasing. Nonpoint source runoff could be a contributing factor to the observed increases in chloride and sulfate.

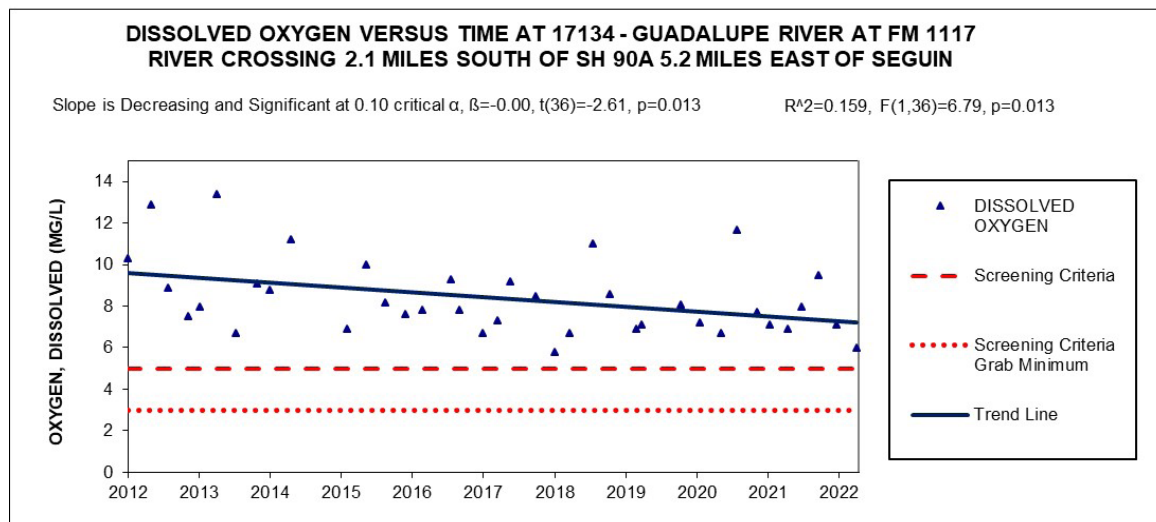
Figure 23: Dissolved oxygen trend at Station 17134

A decreasing trend for dissolved oxygen was also found at station 17134. This decrease is not significantly correlated with stream flow. This segment of river is infested with several different species of invasive species which may be contributing to this trend.

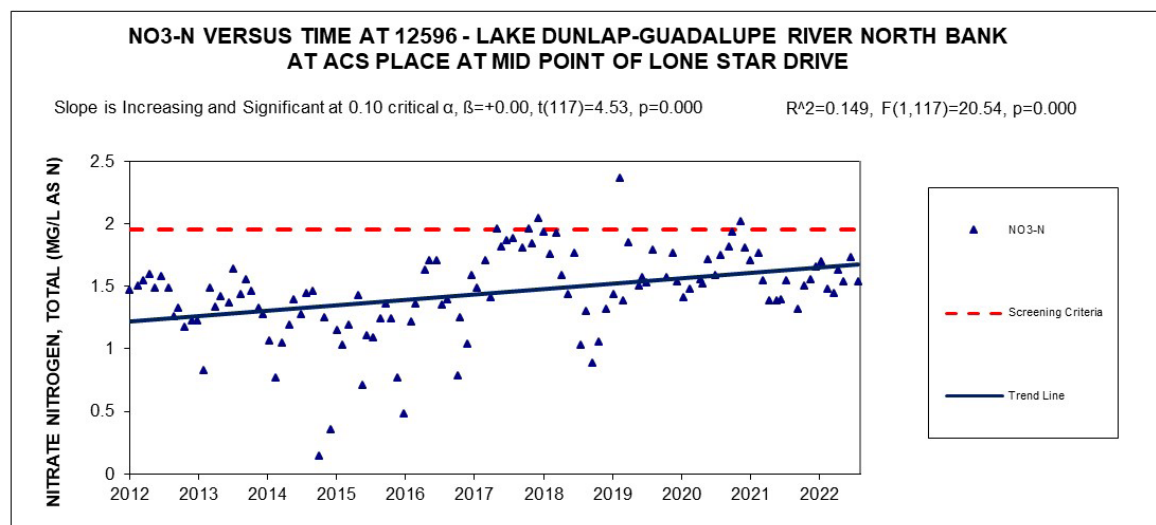
Figure 24: Nitrate trend at Station 12596

An increasing trend in nitrate was identified at station 12596. This station is located on Lake Dunlap, a heavily urbanized area. Fertilizer runoff from lawns that cover a large area of the land directly around the lake could be contributing to this increase. Wastewater effluent could also be contributing to the increase. Education to local homeowners on proper use of fertilizers, and more efficient wastewater treatment could help mitigate this increase.

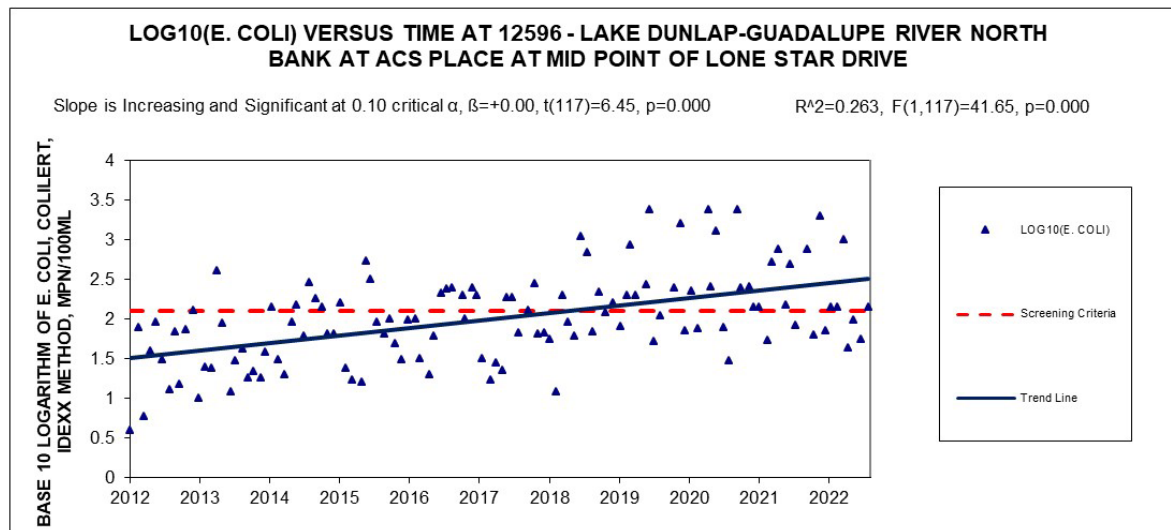
Figure 25: Log10 *E.coli* trend at Station 12596

Data analysis also showed an increasing trend in *E. coli* at station 12596. Changes in rainfall patterns could be a contributing factor, as *E. coli* loading can be higher after a heavy rainfall event that follows a period of drought.

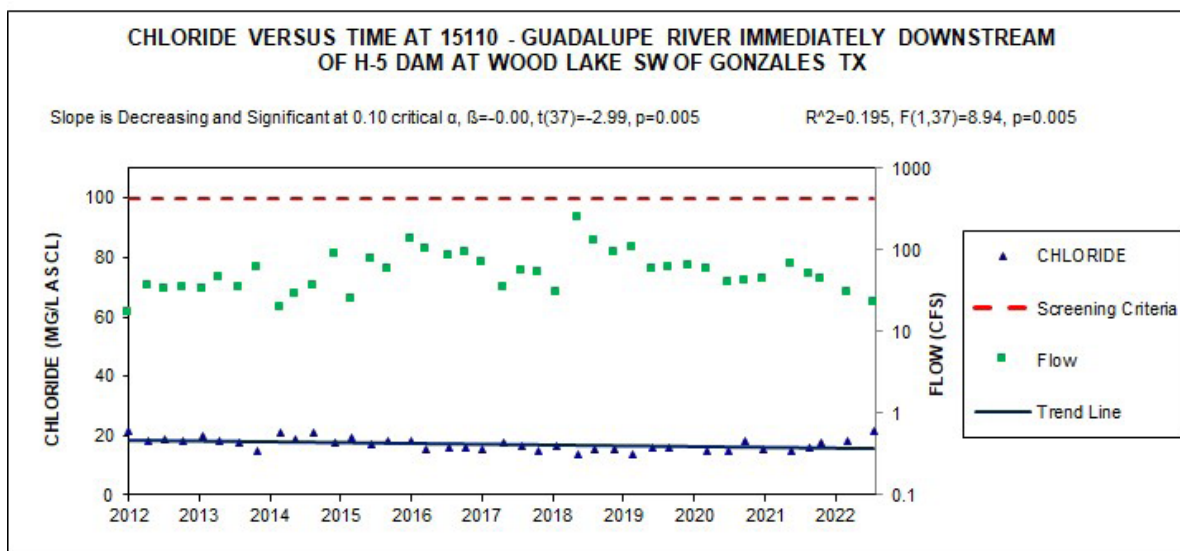
Figure 26: Chloride trend at Station 15110

A decreasing trend in chloride was seen at station 15110, which is located in the lower portion of the segment. This trend is inversely correlated with flow.

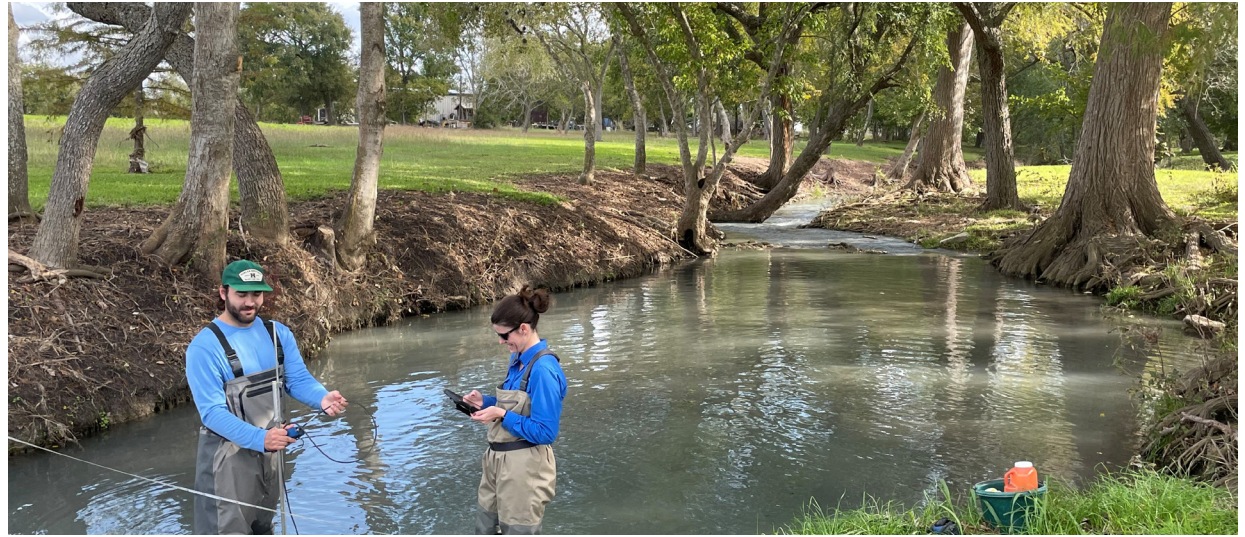
GBRA Water Quality Team Conducting Flow Measurement on Geronimo Creek

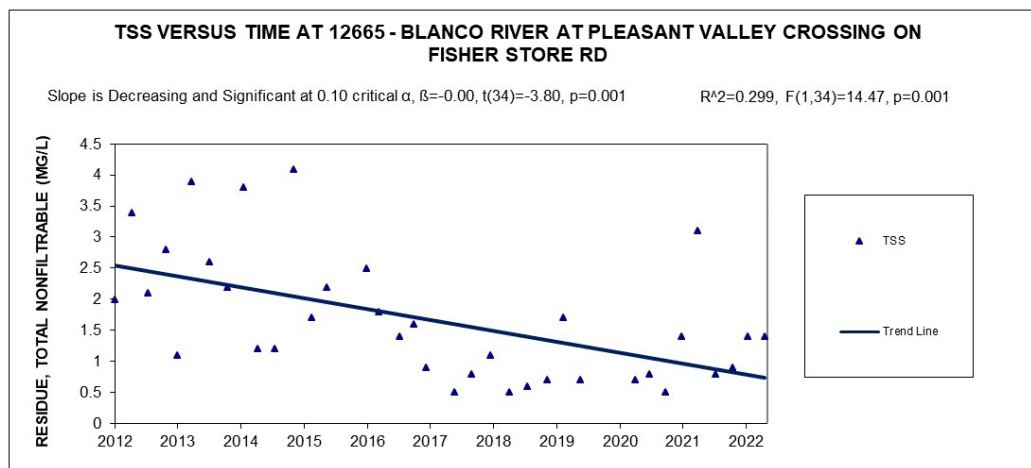
Figure 28: TSS trends at Station 12665

Data analyses indicate a decreasing trend for total suspended solids (TSS) at all stations in segment 1813. Data from station 12665 is shown here (Figure 28). Some stakeholders have hypothesized that the decrease could be due to more efficient treatment of wastewater upstream or due to a decrease in the amount of construction happening near the river.

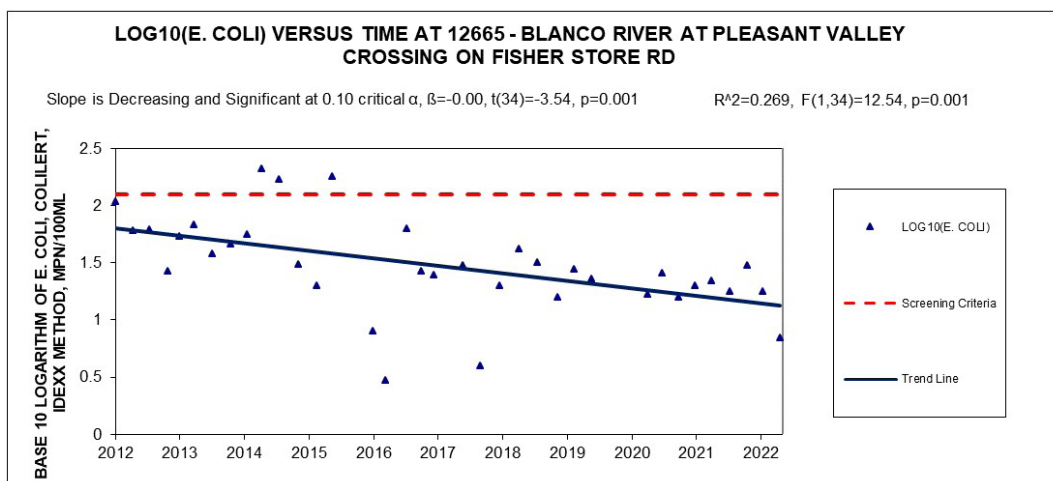
Figure 29: E.coli trend at Station 12665

Analyses also show a decreasing trend for E. coli at several sites in segment 1813, including 12663, 12665, and 12668. Data from 12665 are shown here (Figure 29). Other notable trends at station 12668 include increasing trends in sulfate (Figure 30) and chloride (Figure 31), and a decreasing trend in chlorophyll a (Figure 32). These trends may be a result of decreased runoff due to a lower than average rainfall and as a result, a proportionally larger influence from groundwater.

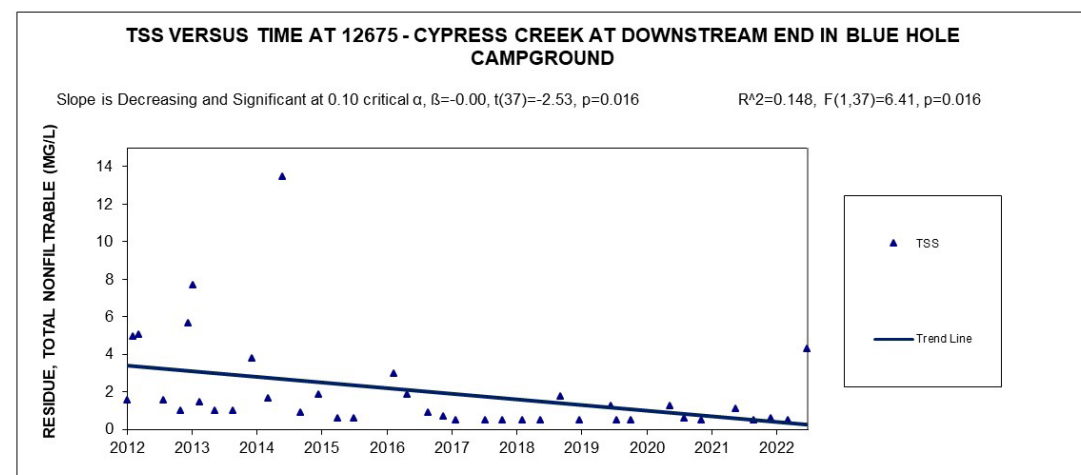
Figure 35: Total suspended solids trend at Station 12674

Analysis also showed a decreasing trend for TSS (Figure 35) at station 12675. The reason for this decrease is unknown.

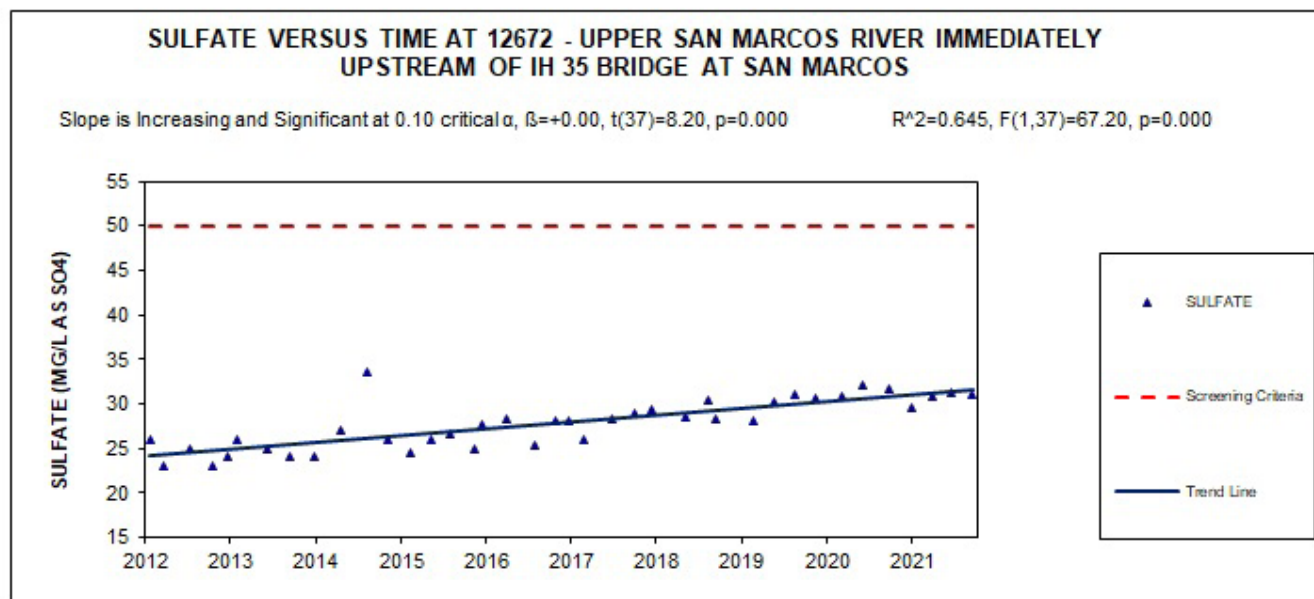
Figure 38: Sulfate trend at Station 12672

Analysis of data from station 12672 showed increasing trends in sulfate (Figure 38) and chloride (Figure 39). These increases were not significantly correlated with flow. It is unclear what is causing these increases, however runoff could be a contributing factor.

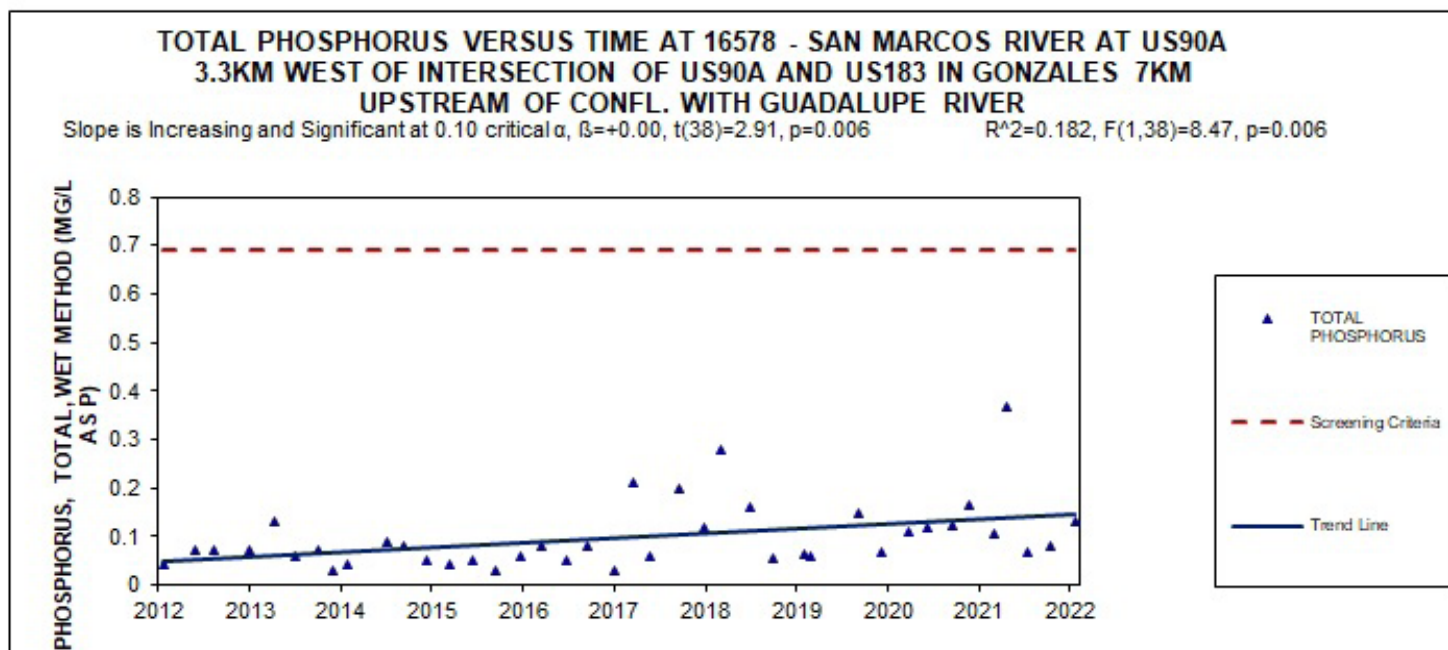
Figure 42: Total phosphorus trend at Station 16578

Data showed an increasing trend for total phosphorus at station 16578 (Figure 42). This station is located in a rural area and agriculture is common in this portion of the watershed. Nonpoint source runoff could be contributing to this trend. Increased phosphorus can lead to algal blooms and eutrophication. Management of nonpoint source runoff in this area could help mitigate this increase in phosphorous before it becomes an issue.

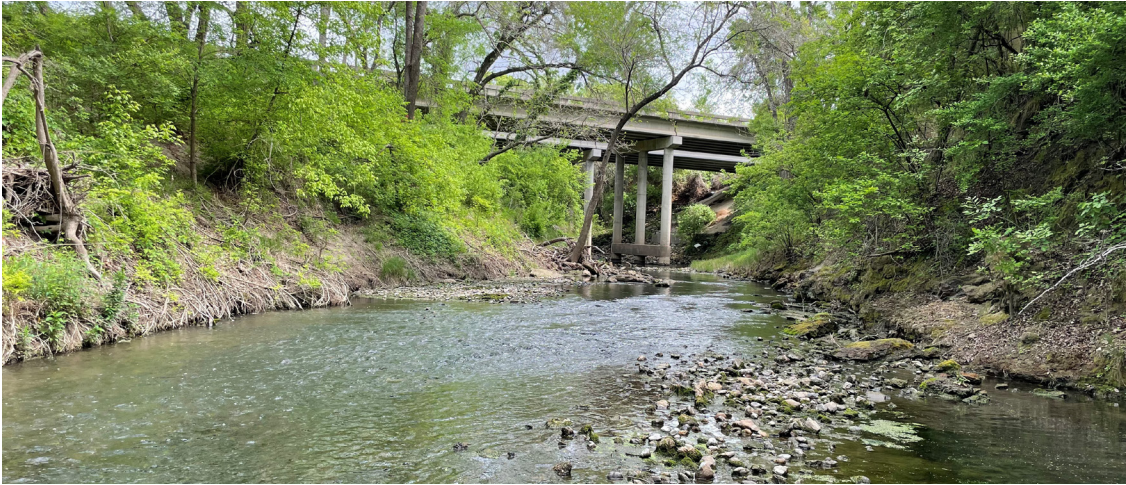
Photo 9: Plum Creek near CR135 in Luling

in this watershed range from dark waxy soils to sandy or grey loam. Plum Creek is prone to erosion and tends to have steep banks and a deep-set stream channel, as shown in Photo 9. This watershed has been historically dominated by rural land uses. However, like many watersheds in the Interstate 35 corridor, it is experiencing rapid urbanization and population increase.

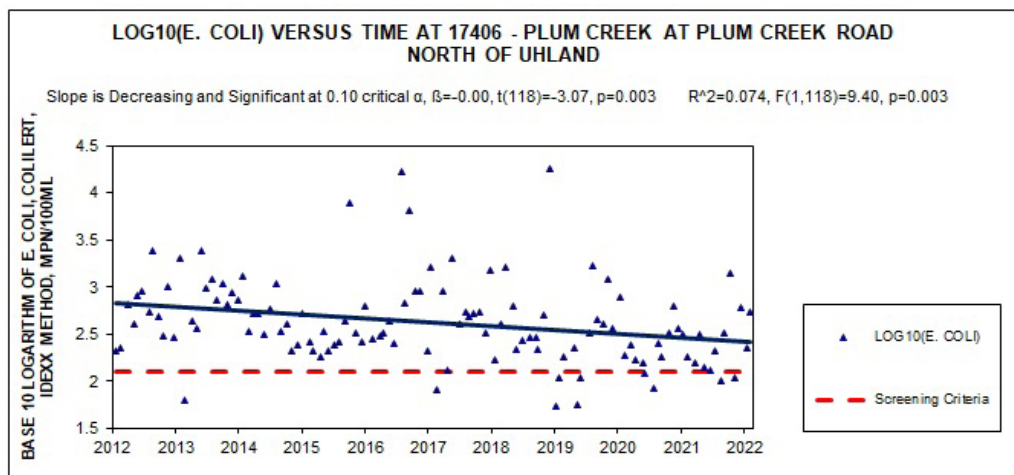
Figure 43: E.coli trend at Station 17406

No significant trends were identified in the middle or lower reaches of this segment. In the upper reach of the segment, analyses show a decreasing trend in *E. coli* over time (Figure 43). This improvement may be related to implementation of BMPs through the WPP. Other factors contributing to the decrease might be more efficient wastewater treatment, or an increase in flow over time.

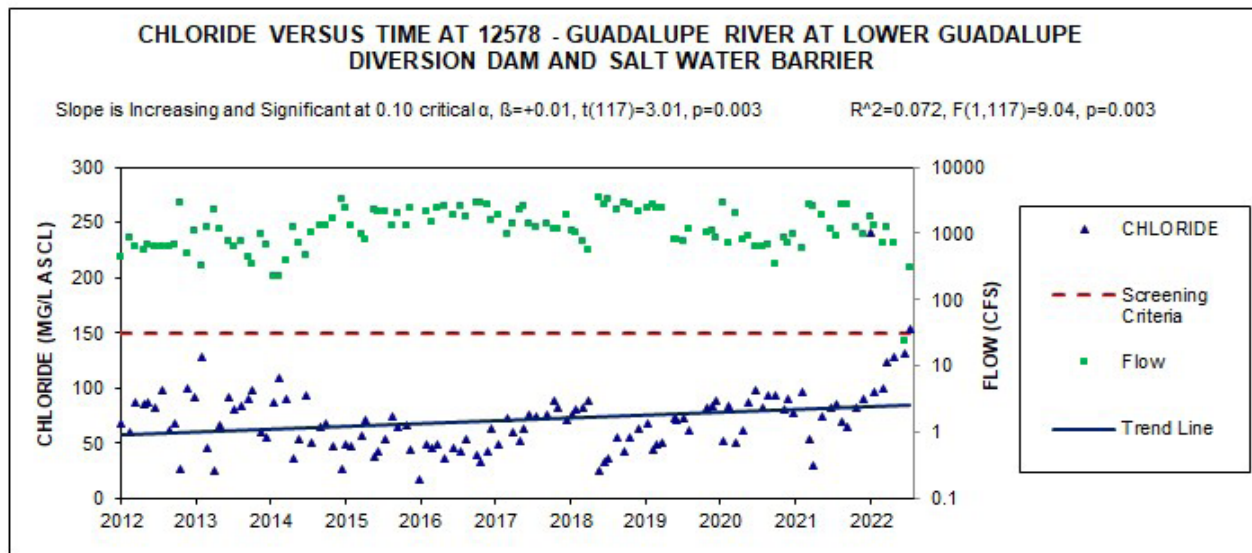
Figure 45: Chloride trend at Station 12578

Trend analyses performed on data from this segment show an increasing trend for chloride (Figure 45), and grab samples collected in 2021 exceeded the screening criteria for chloride for the first time during the reported period. This segment receives considerable inflow from the San Antonio River, which could be a contributing factor to this increase. Another potential contributor to the increase in chlorides could be saltwater intrusion.

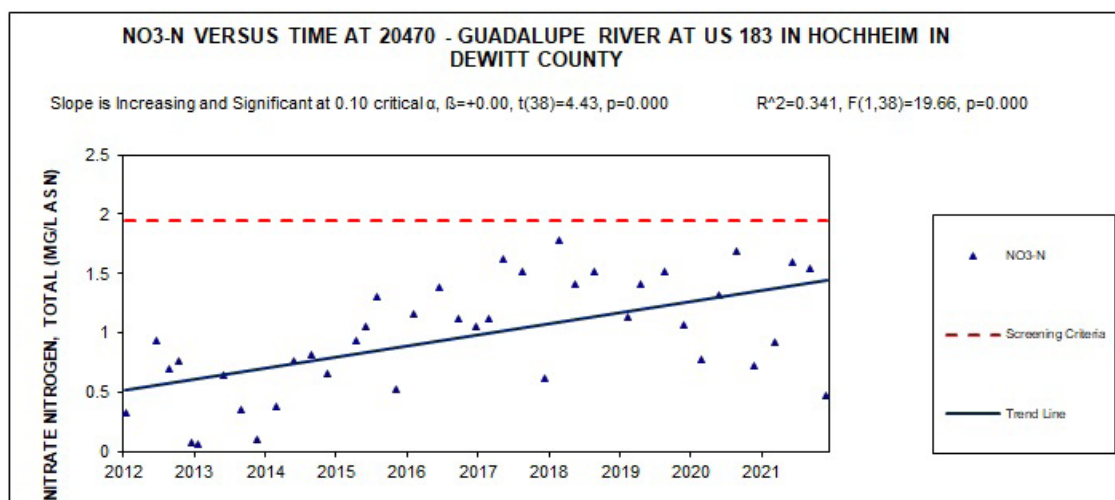
Figure 46: Nitrate trend at Station 20470

Though still below the screening level, analyses showed increasing trends for nitrate-nitrogen at all three stations in this segment. Data from station 20470 is shown here (Figure 46). Increased non-point source pollution from agriculture in the surrounding watershed could be a contributing factor.

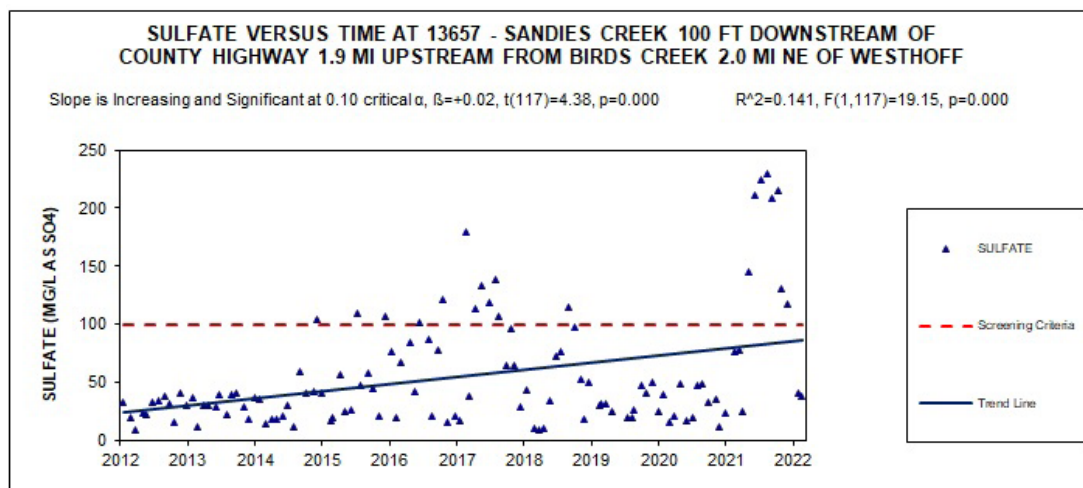
Figure 47: Sulfate trend at Station 13657

Data analyzed from station 13657 showed an increasing trend in sulfate over time (Figure 47). Increased runoff from oil field activity in the area could be a cause of this increase.

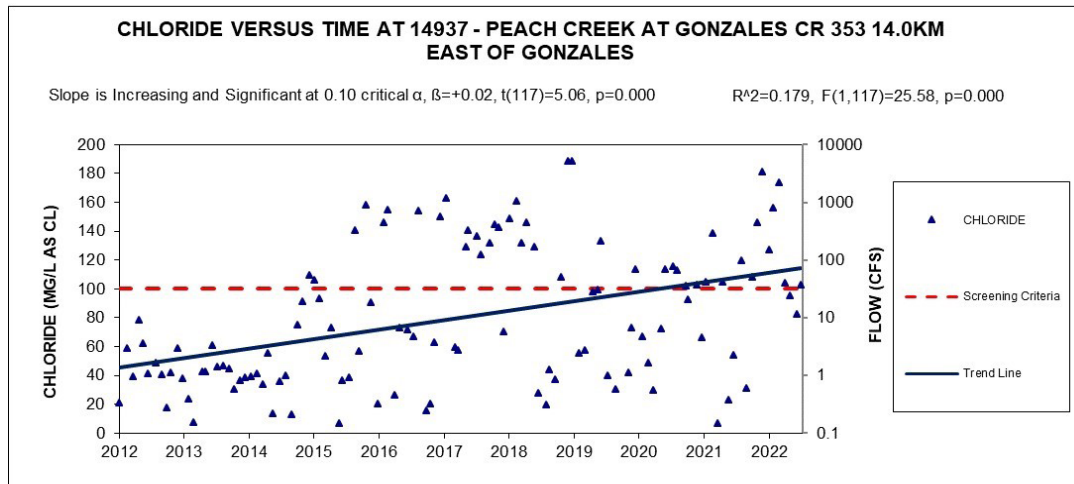
Figure 48: Chloride trend at Station 14937

Data from station 14937 show an increasing trend in chlorides (Figure 48) and TDS (Figure 49). This could be due to decreased flows over time, or possibly a result of upstream discharges from wastewater or industrial effluent.
