GUADALUPE RIVER BELOW COMAL RIVER

Segment 1804 - Guadalupe River Below Comal River

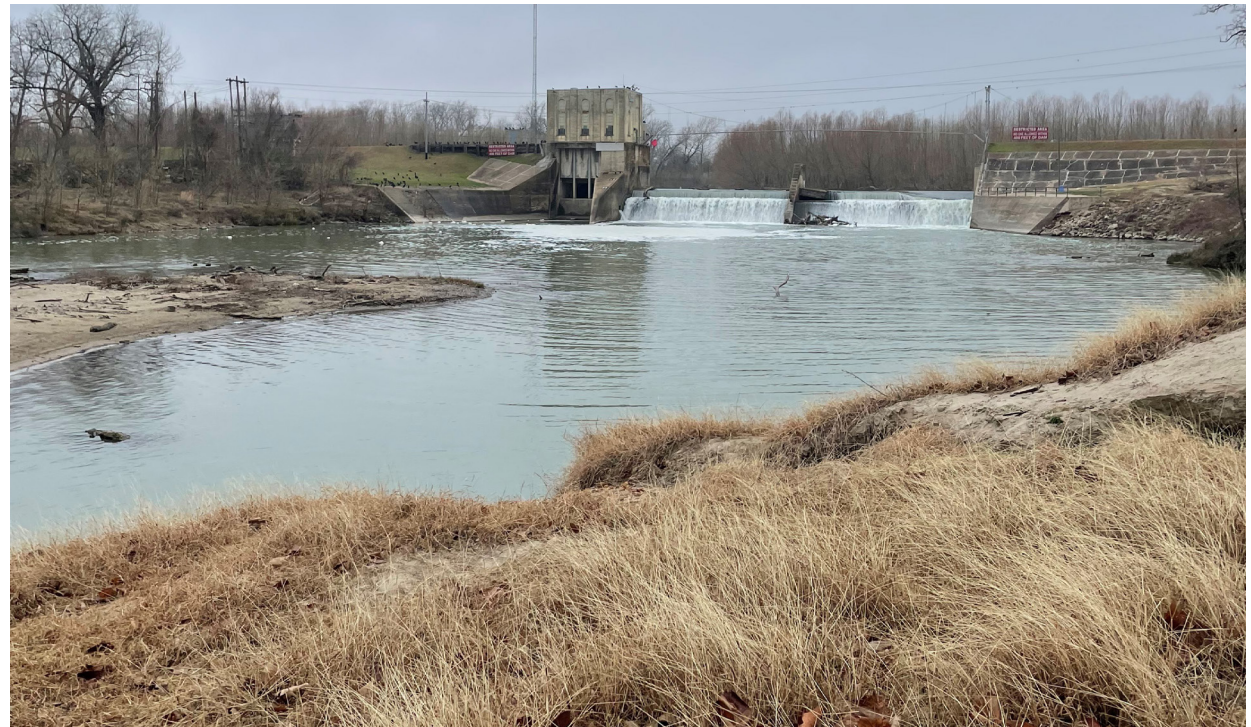
Guadalupe River at H5 Dam

This segment experiences a 300-foot drop in elevation as it flows south. This elevation change created an ideal location for the construction of six hydroelectric dams to provide power to the surrounding area. The dams were constructed in the 1920s to 1930s and GBRA took ownership in 1963. Unlike Canyon Dam, which is a flood control structure, these are pass-through dams that do not control flood waters. Because of the relatively high velocity of the water flowing through these impoundments (referred to collectively as the Guadalupe Valley Lakes), water quality is significantly different than in larger reservoirs. Stratification, which occurs in Canyon Reservoir, does not occur in these impoundments. Recreation including boating, fishing, and water skiing are extremely popular on the Guadalupe Valley Lakes. The land surrounding Lake Dunlap, Lake McQueeney, and Lake Placid is urban and located in the rapidly expanding I-35 corridor. The watershed surrounding the lower three lakes is more rural. Over time as the dam structures have aged, they have exceeded their useful life expectancy period and are no longer structurally sound. In recent years, several of the structures have failed despite regular maintenance, and replacement of several of the dams is taking place.
