Segment 1806 comprises the 103 mile portion of the Guadalupe River that flows from the confluence between the North Fork and South Forks in Kerr County to Canyon Reservoir in Comal County. This summary report will discuss this segment as two sub-watersheds in order to better describe the effects of a Total Maximum Daily Load (TMDL) implementation plan that has been put into place upstream of Flat Rock Dam in the City of Kerrville. The TCEQ has divided this segment into eight assessment units (AUs). The three AUs that describe the lower sub-watershed below Flat Rock Dam are 1806\_02 from the confluence with Big Joshua Creek to Flat Rock dam in Kerrville, 1806\_08 from the confluence with Honey Creek upstream to the confluence with Big Joshua Creek and 1806\_01 which covers the lower 25 miles of segment from 1.7 miles downstream of Rebecca Creek Road up to the confluence with Honey Creek. These three AUs represent over 93% of the total river reach for this segment. For information regarding the remaining five AUs in this segment please refer to the section of this report covering the Guadalupe River above Flat Rock Dam.

### **Guadalupe River below Flat Rock Dam**

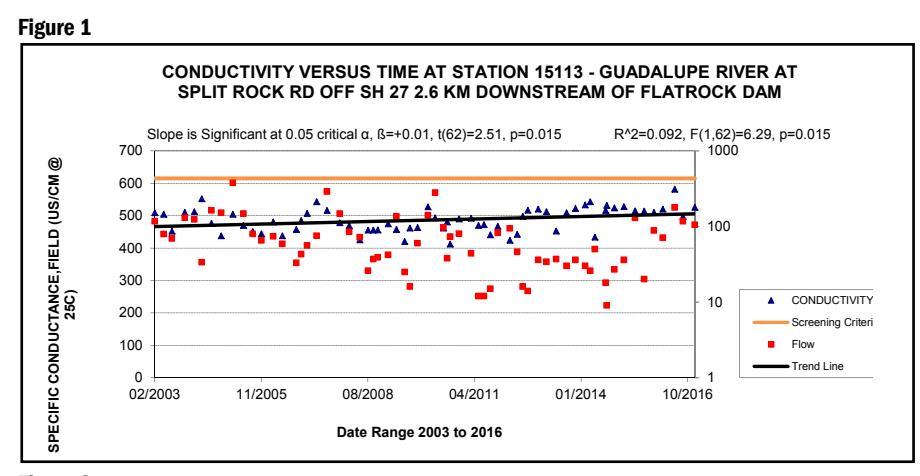
Figure 2

extended drought that began in 2008. GBRA. There are two USGS gages located in this AU, two miles downstream of Flat Rock Dam and downstream of the City of Comfort. The UGRA performs routine sampling at four stations within the AU. The most upstream monitoring station located on this AU is 15113, which is located off Split Rock Road near SH 27, ~1.5 miles downstream of Flat Rock Dam and Kerrville Lake. A regression analysis of the data from June of 2003 to December of 2016 revealed several water quality trends at this station. This station has experienced an increase in specific conductance (TDS is calculated from this measurement), an increase in pH, and a decrease in Total Suspended Solids (Figures 1 & 2 & 3). Although no significant correlations with stream flow
